Bacterial Fluorescence Imaging Affects Wound Management and Engages Patients in Their Care

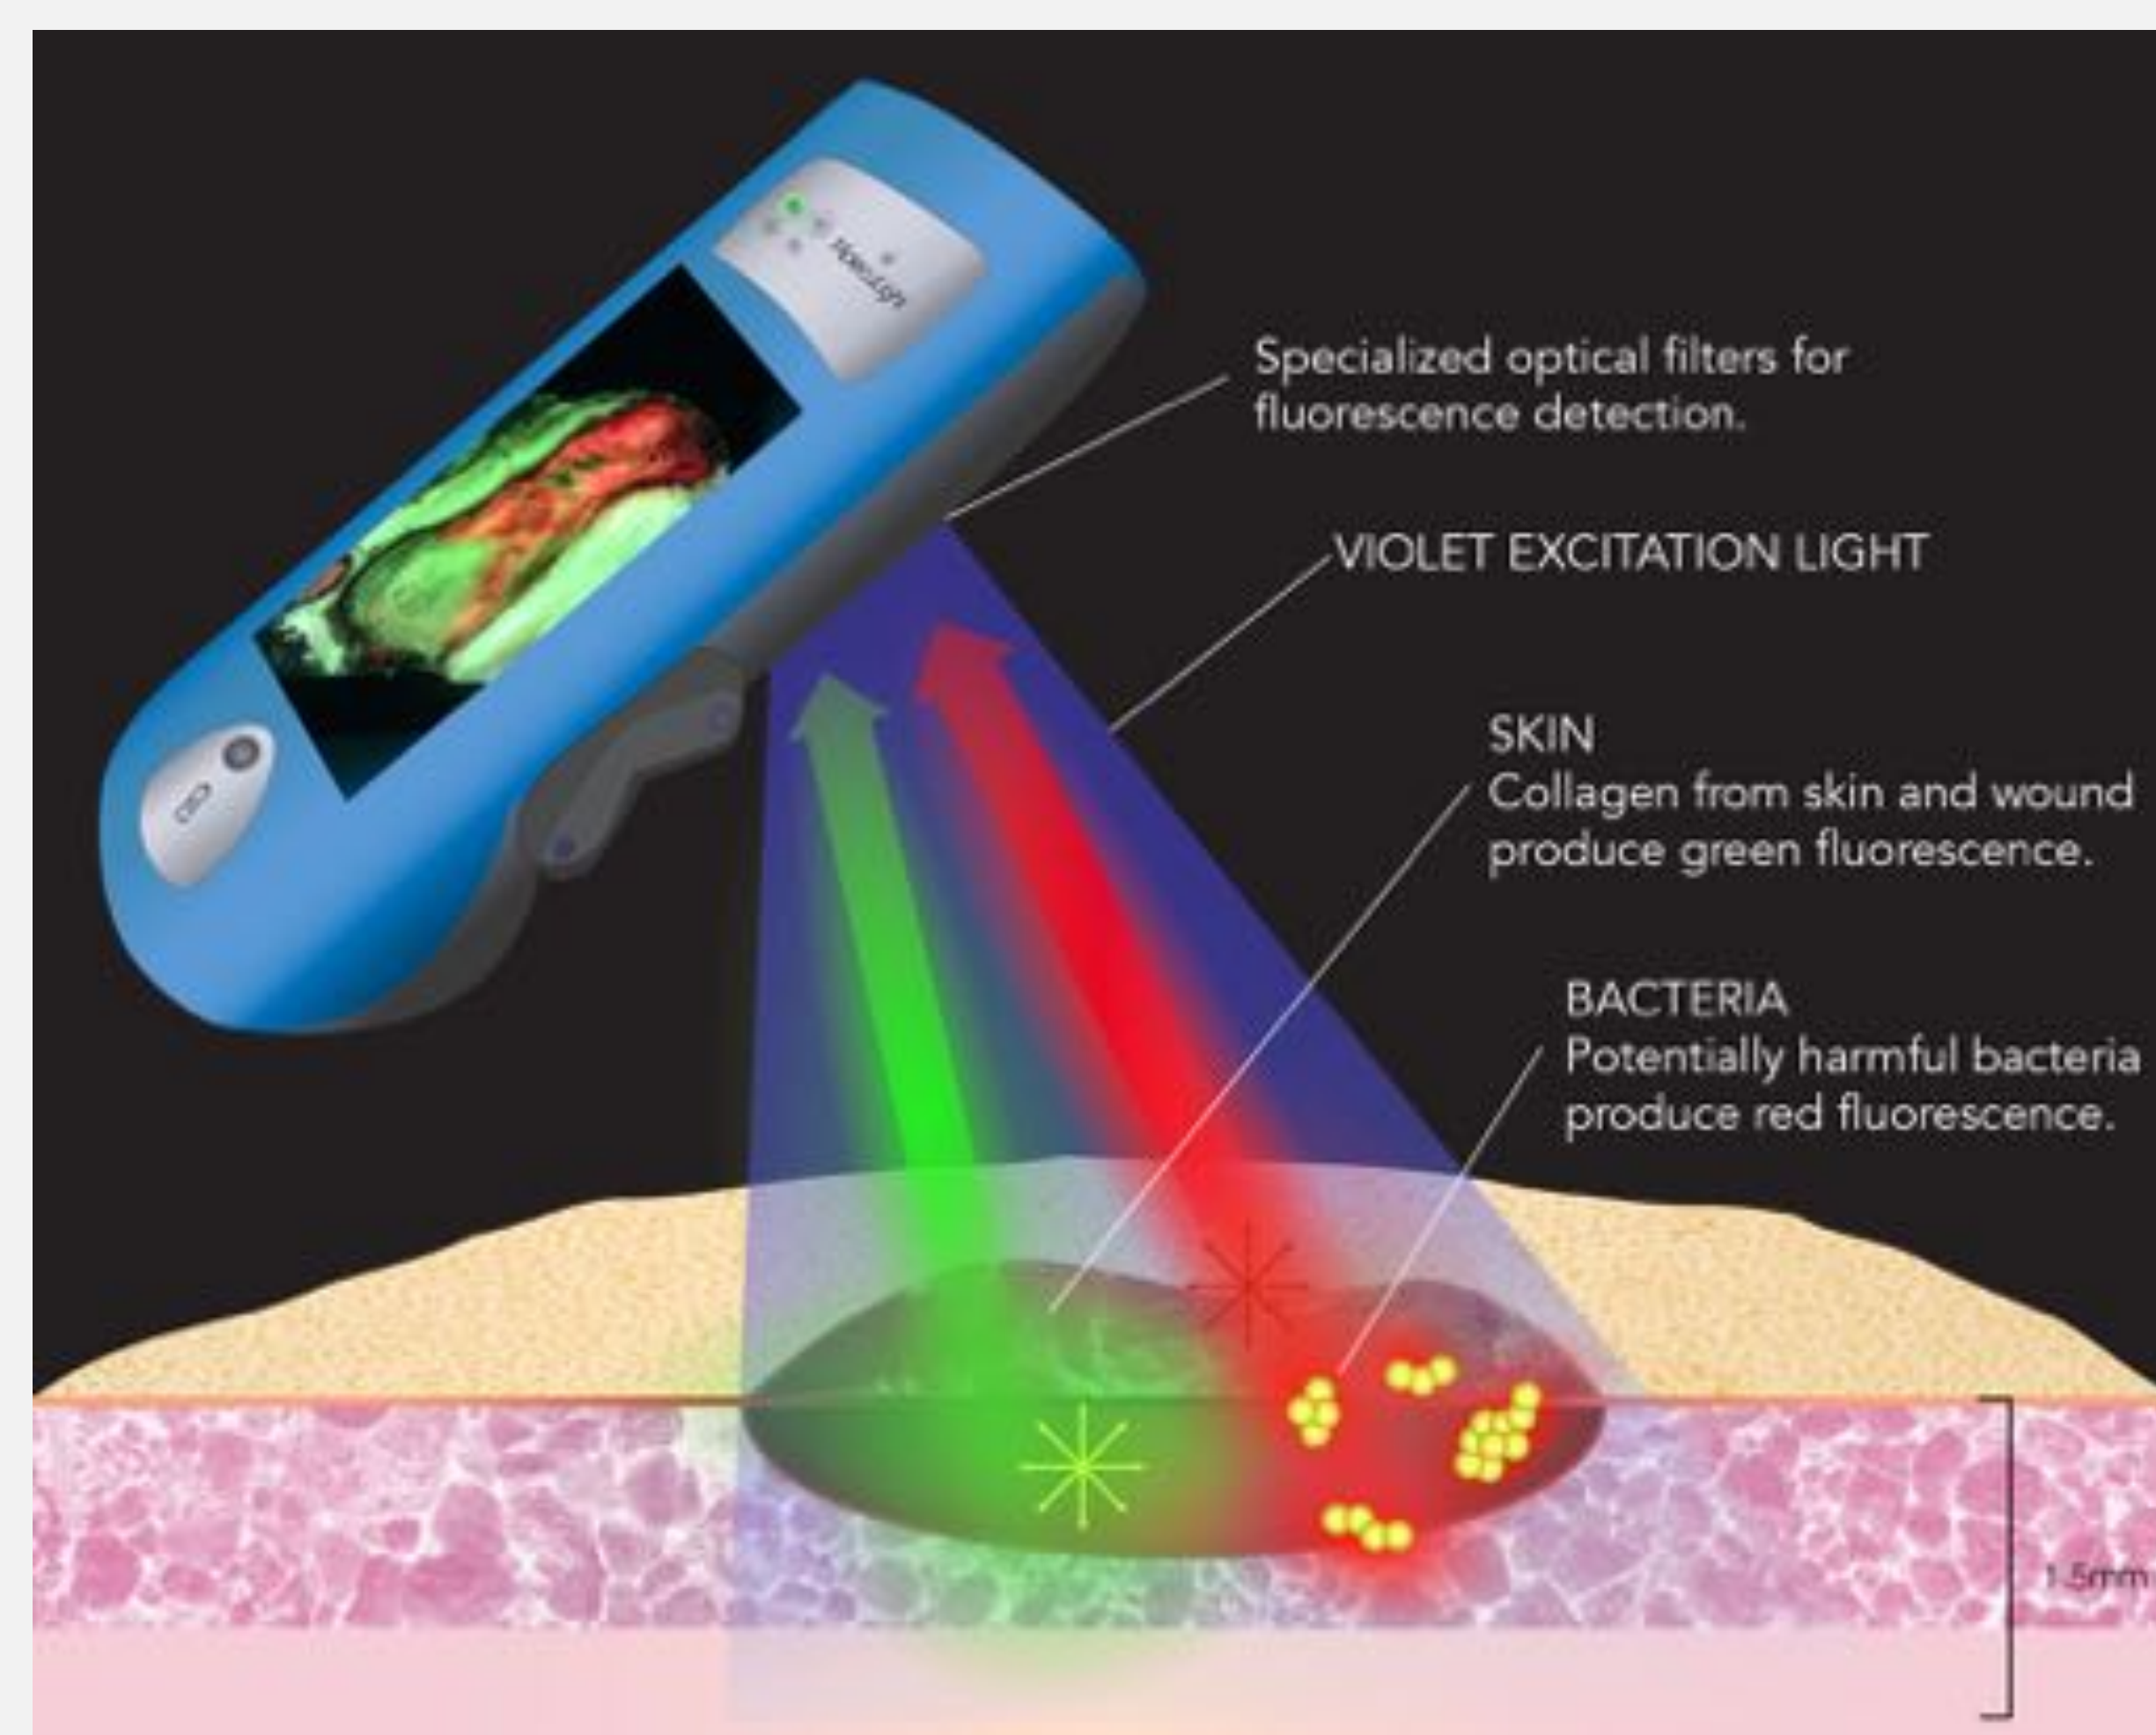
Bacterial Fluorescence Imaging (MolecuLight i:X)

- When excited by 405 nm violet light, tissues fluoresce green while bacteria fluoresce red (porphyrin-producers, e.g. *Staphylococcus aureus*) or cyan (pyoverdine-producing *Pseudomonas aeruginosa*).
- This enables real-time, point-of-care detection and localization of bioburden within and around wounds²⁻⁴.

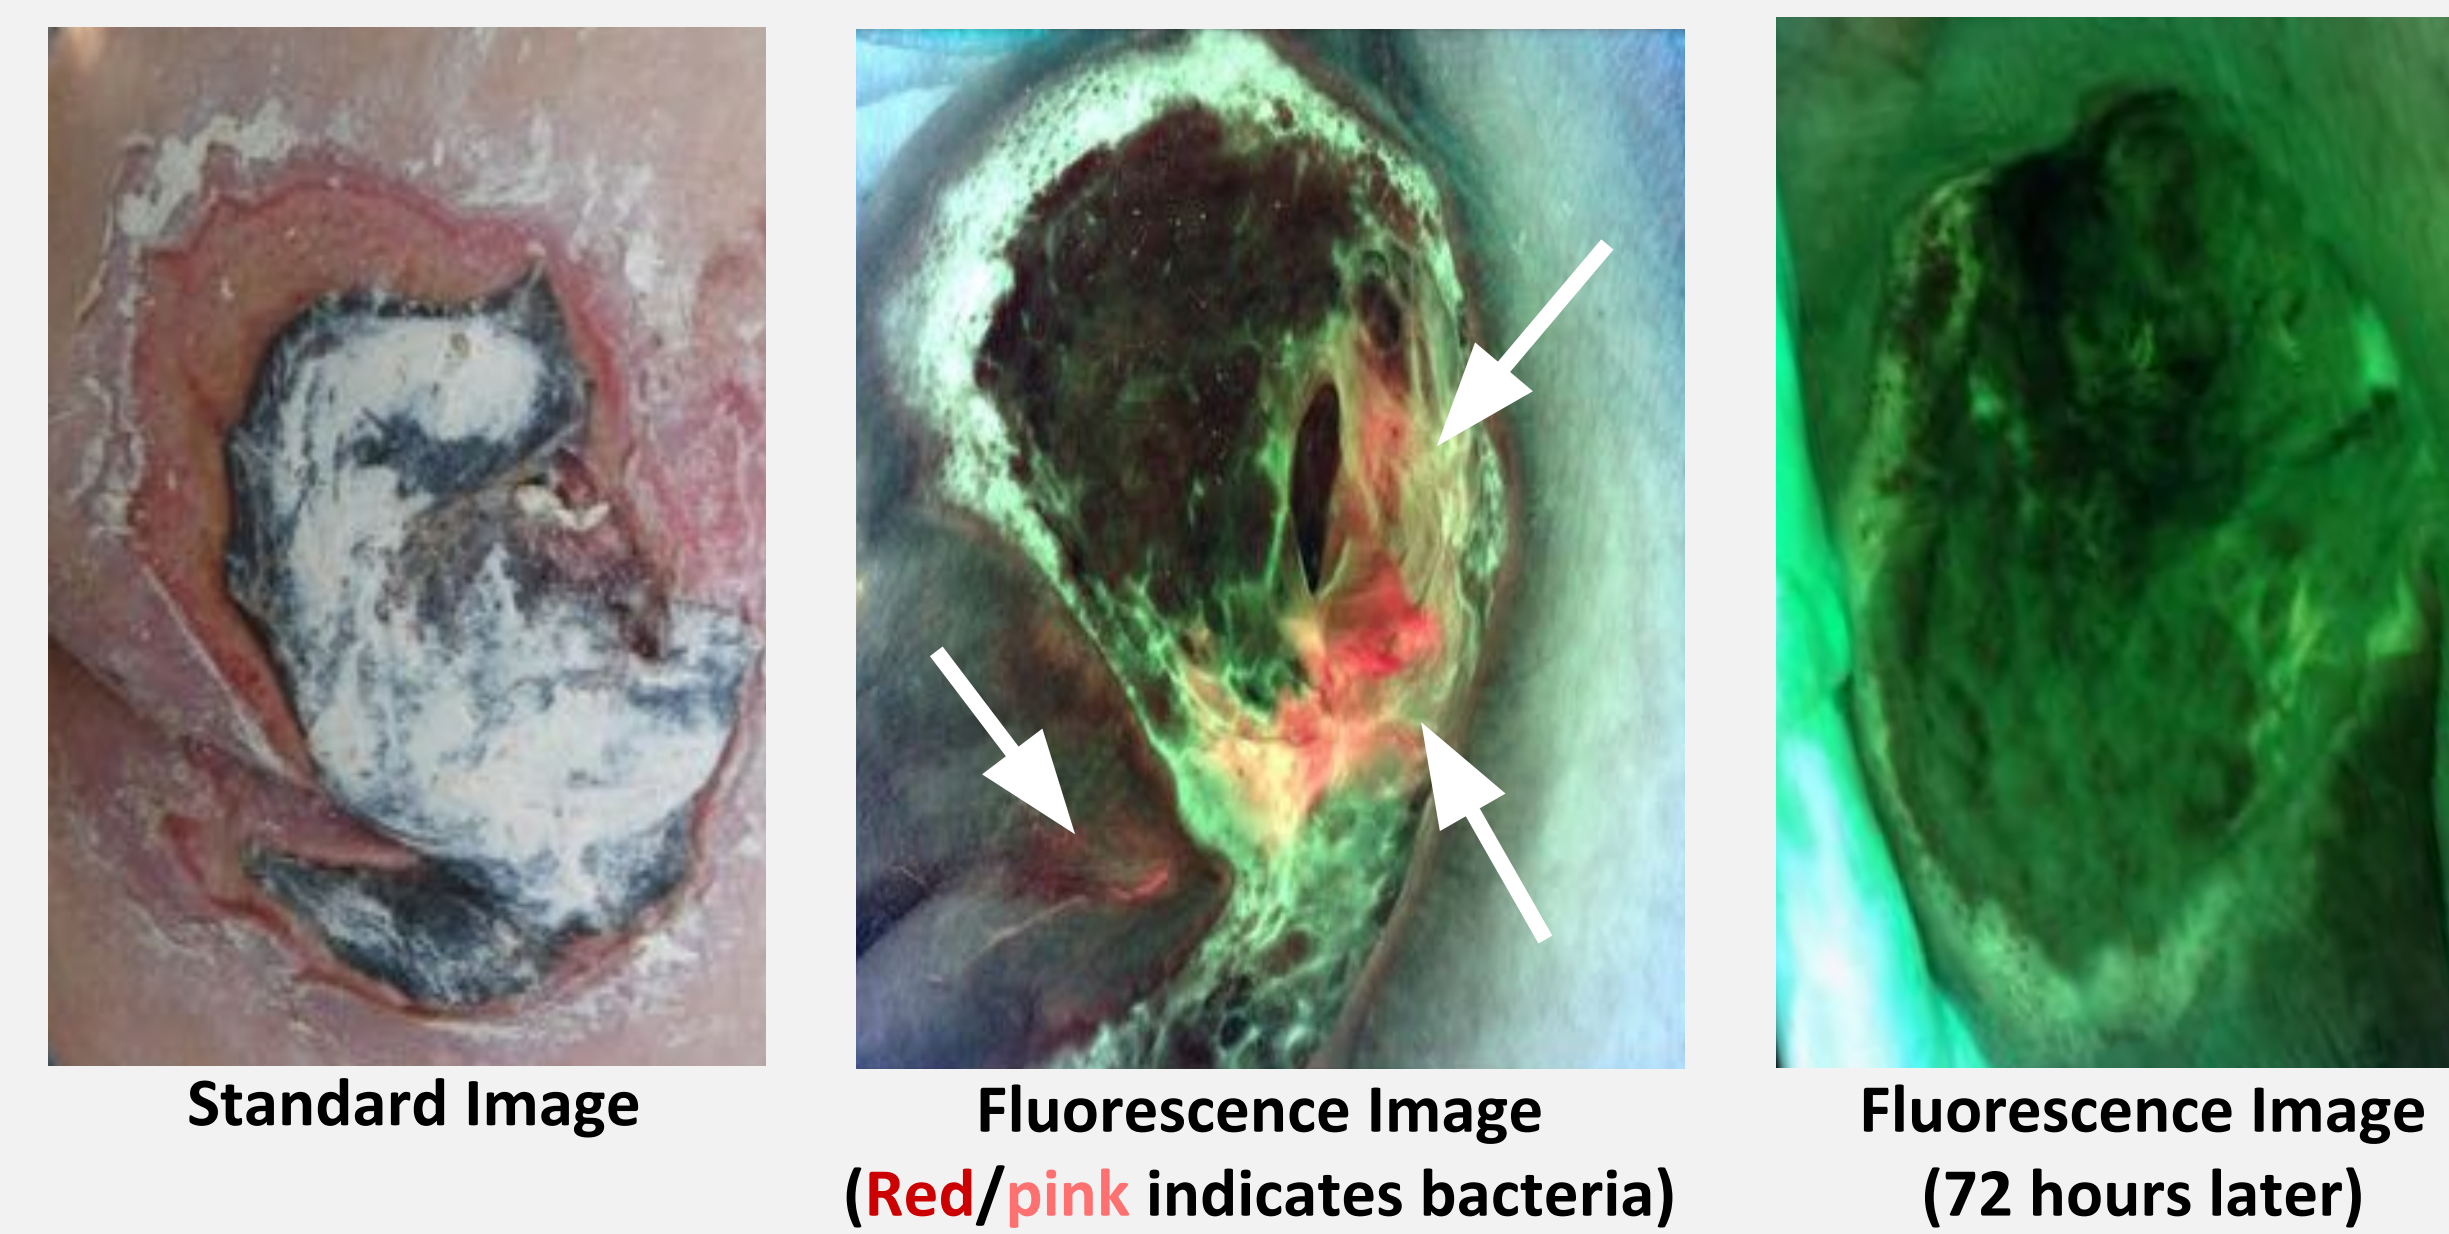
Case 1: Pressure Injury - Coccyx

He had sustained a very large pressure injury and originally had a large black eschar in the buttock region. This eschar area was debrided and a week later the area was imaged with fluorescence. There clearly appeared to be an area of bright red fluorescence and this was then debrided.

72 hours later, repeat fluorescence imaging was deemed negative for heavy bioburden and NPWT was commenced.

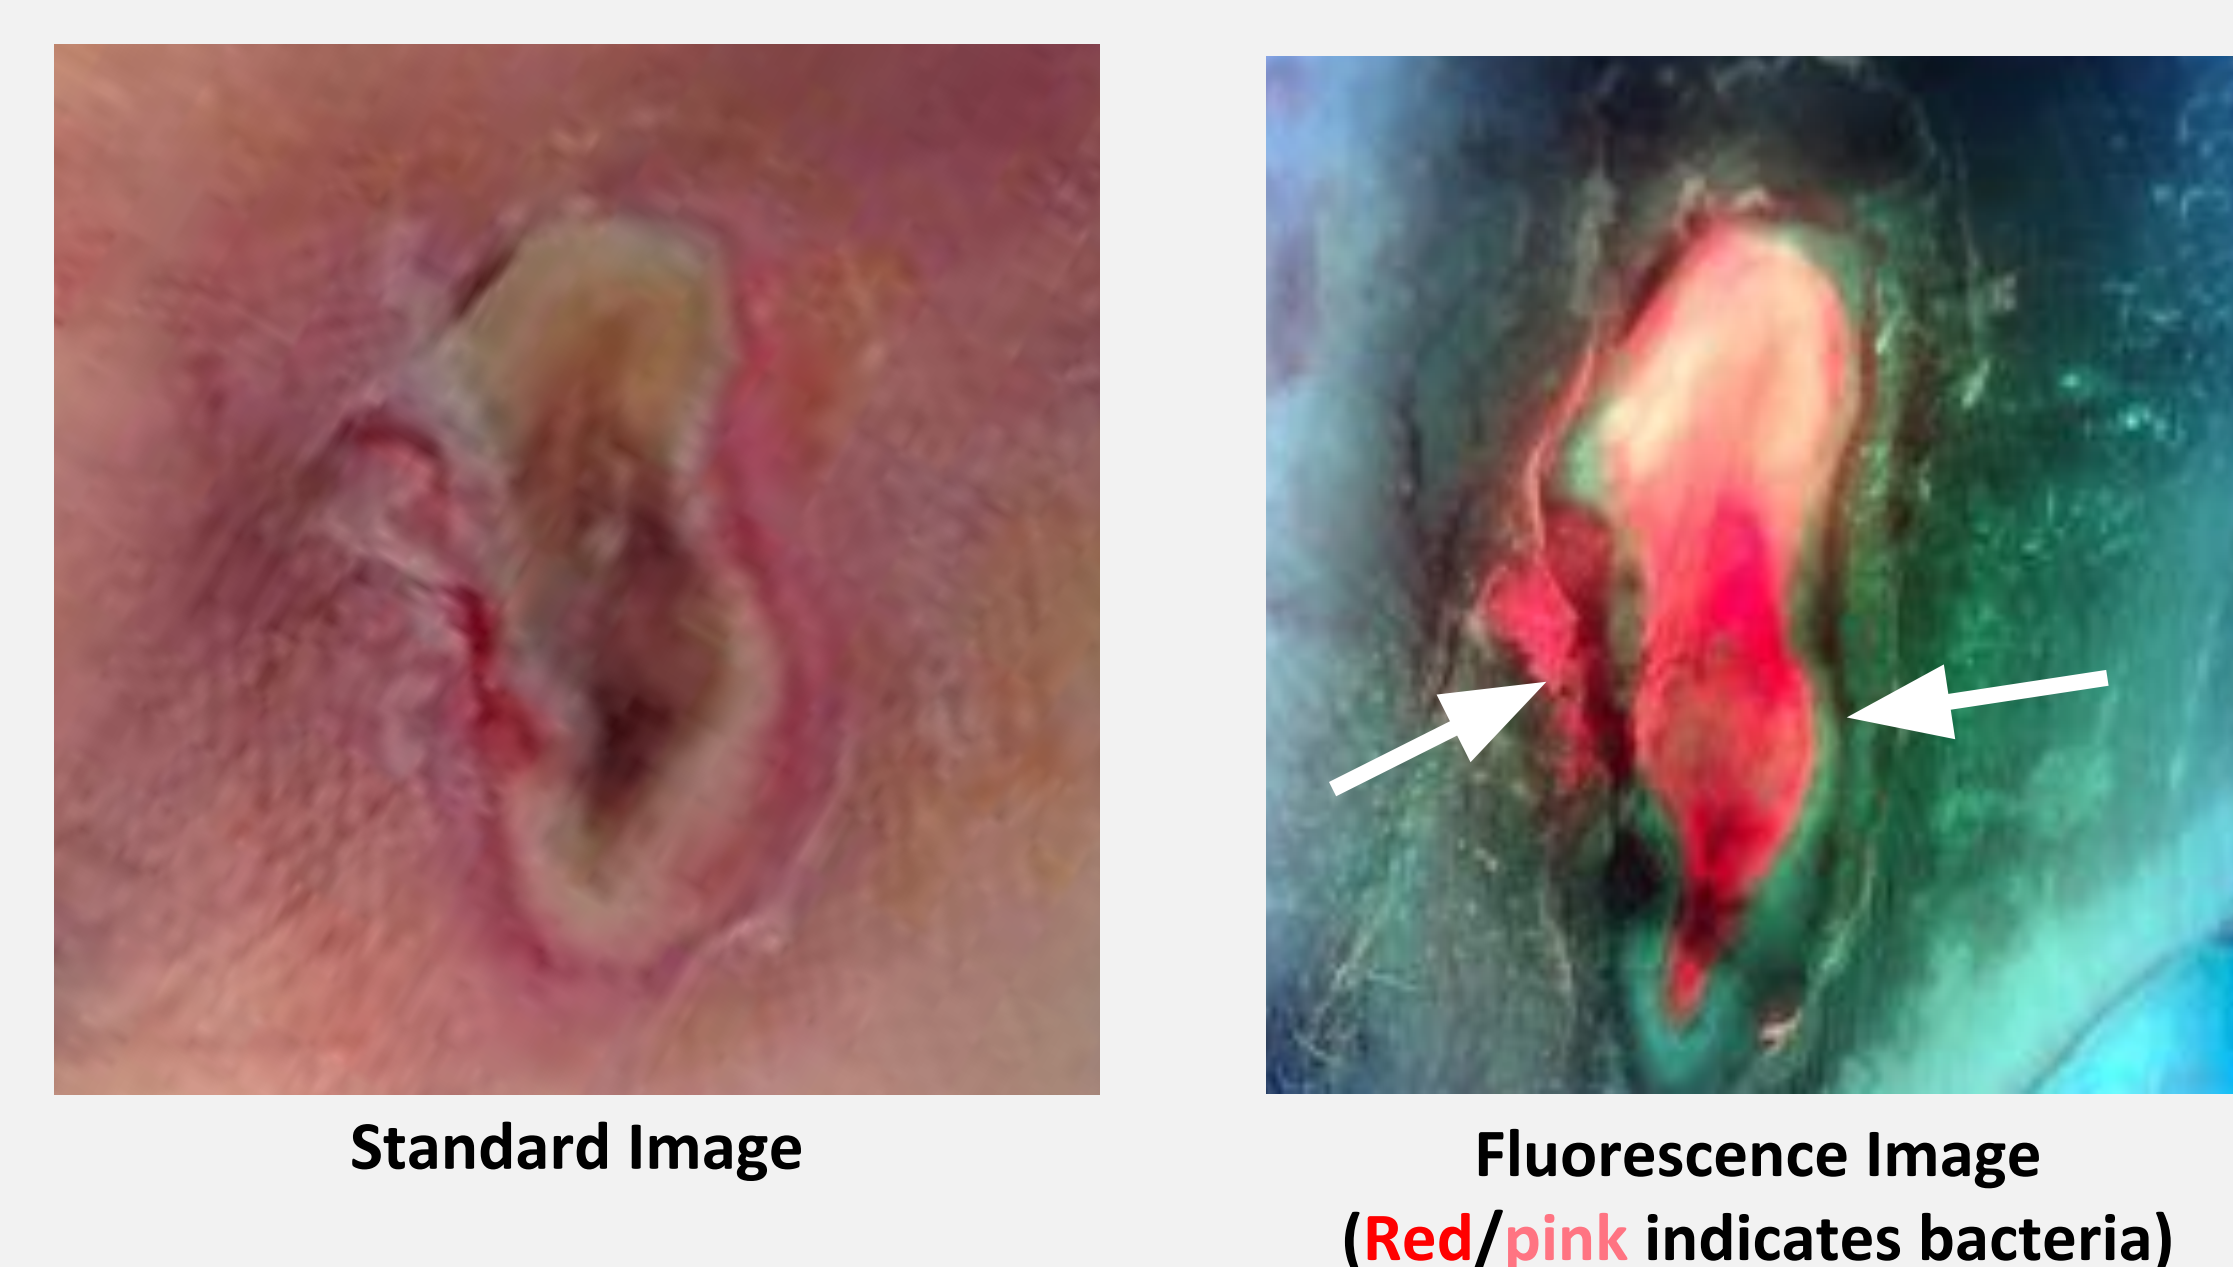
Case 2: Pressure Injury - Coccyx

At the time of fluorescence imaging, plans were underway to send her to a long term care facility. Imaging resulted in targeted swabbing, systemic antibiotics and remaining in an acute care setting.

Swabs confirmed heavy growth of mixed coliforms, *enterococcus*, heavy growth of mixed anaerobes.

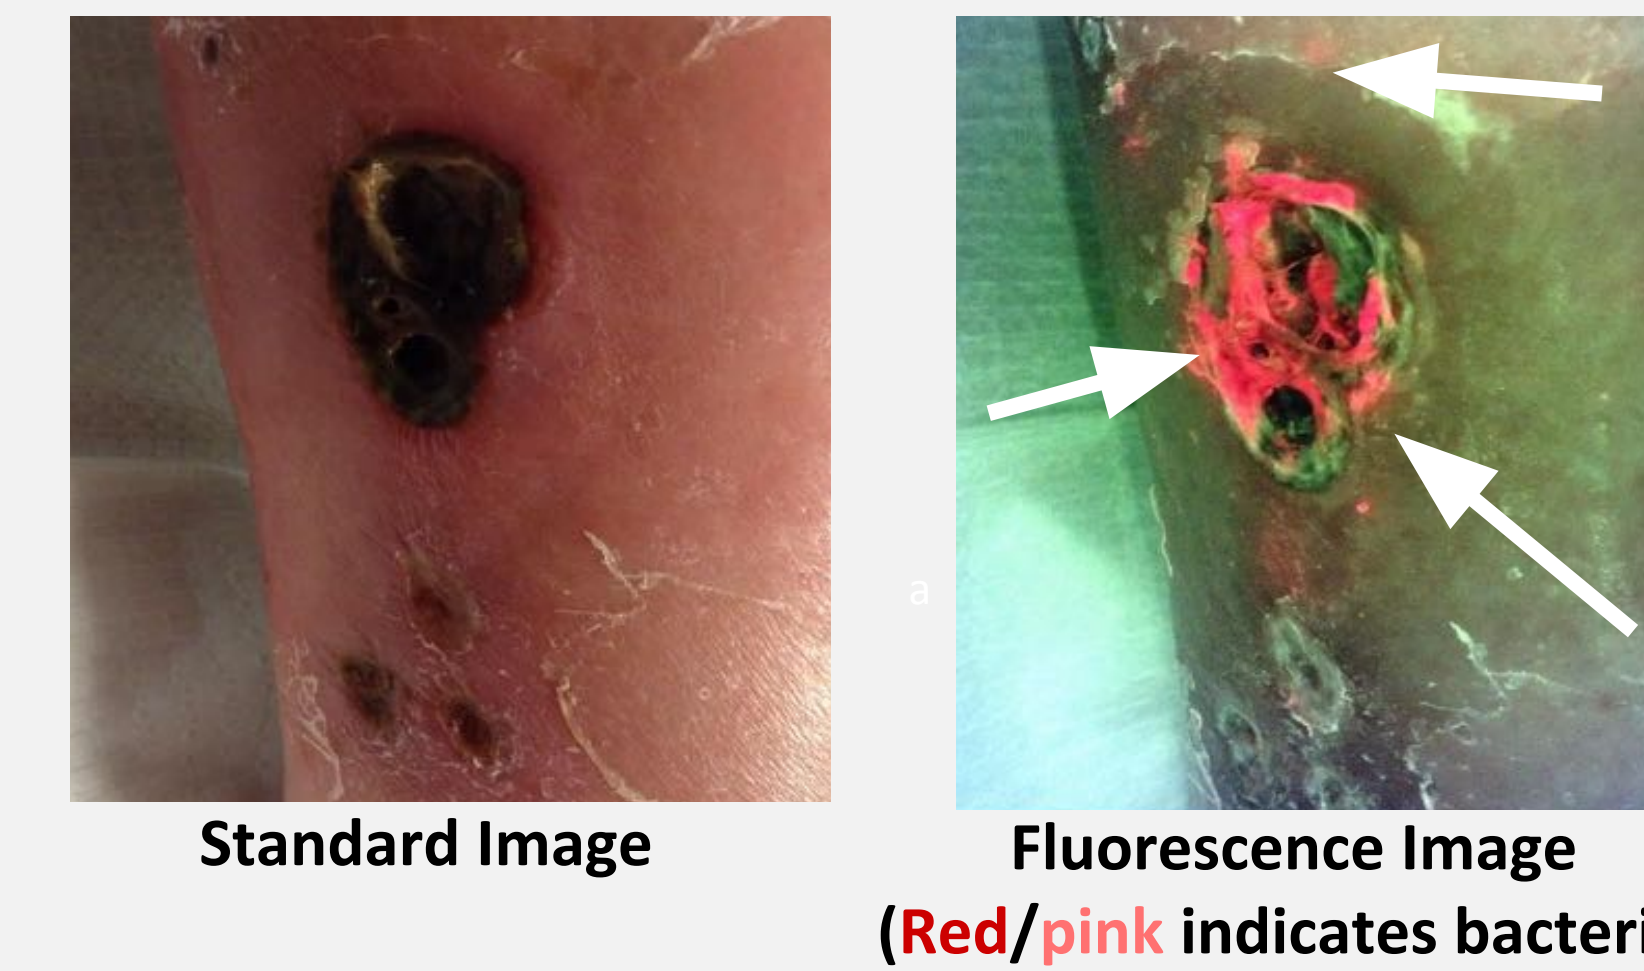
Case 3: Cat Bite

3 weeks after "cat bite" patient developed a painful right leg wound and abscess development. Cultures taken and immediate antimicrobial wound therapy included daily application of cadexomer iodine. Swabs of red/pink region confirmed heavy growth of *Staph aureus*, *Pasteurella multocida*, mixed anaerobes

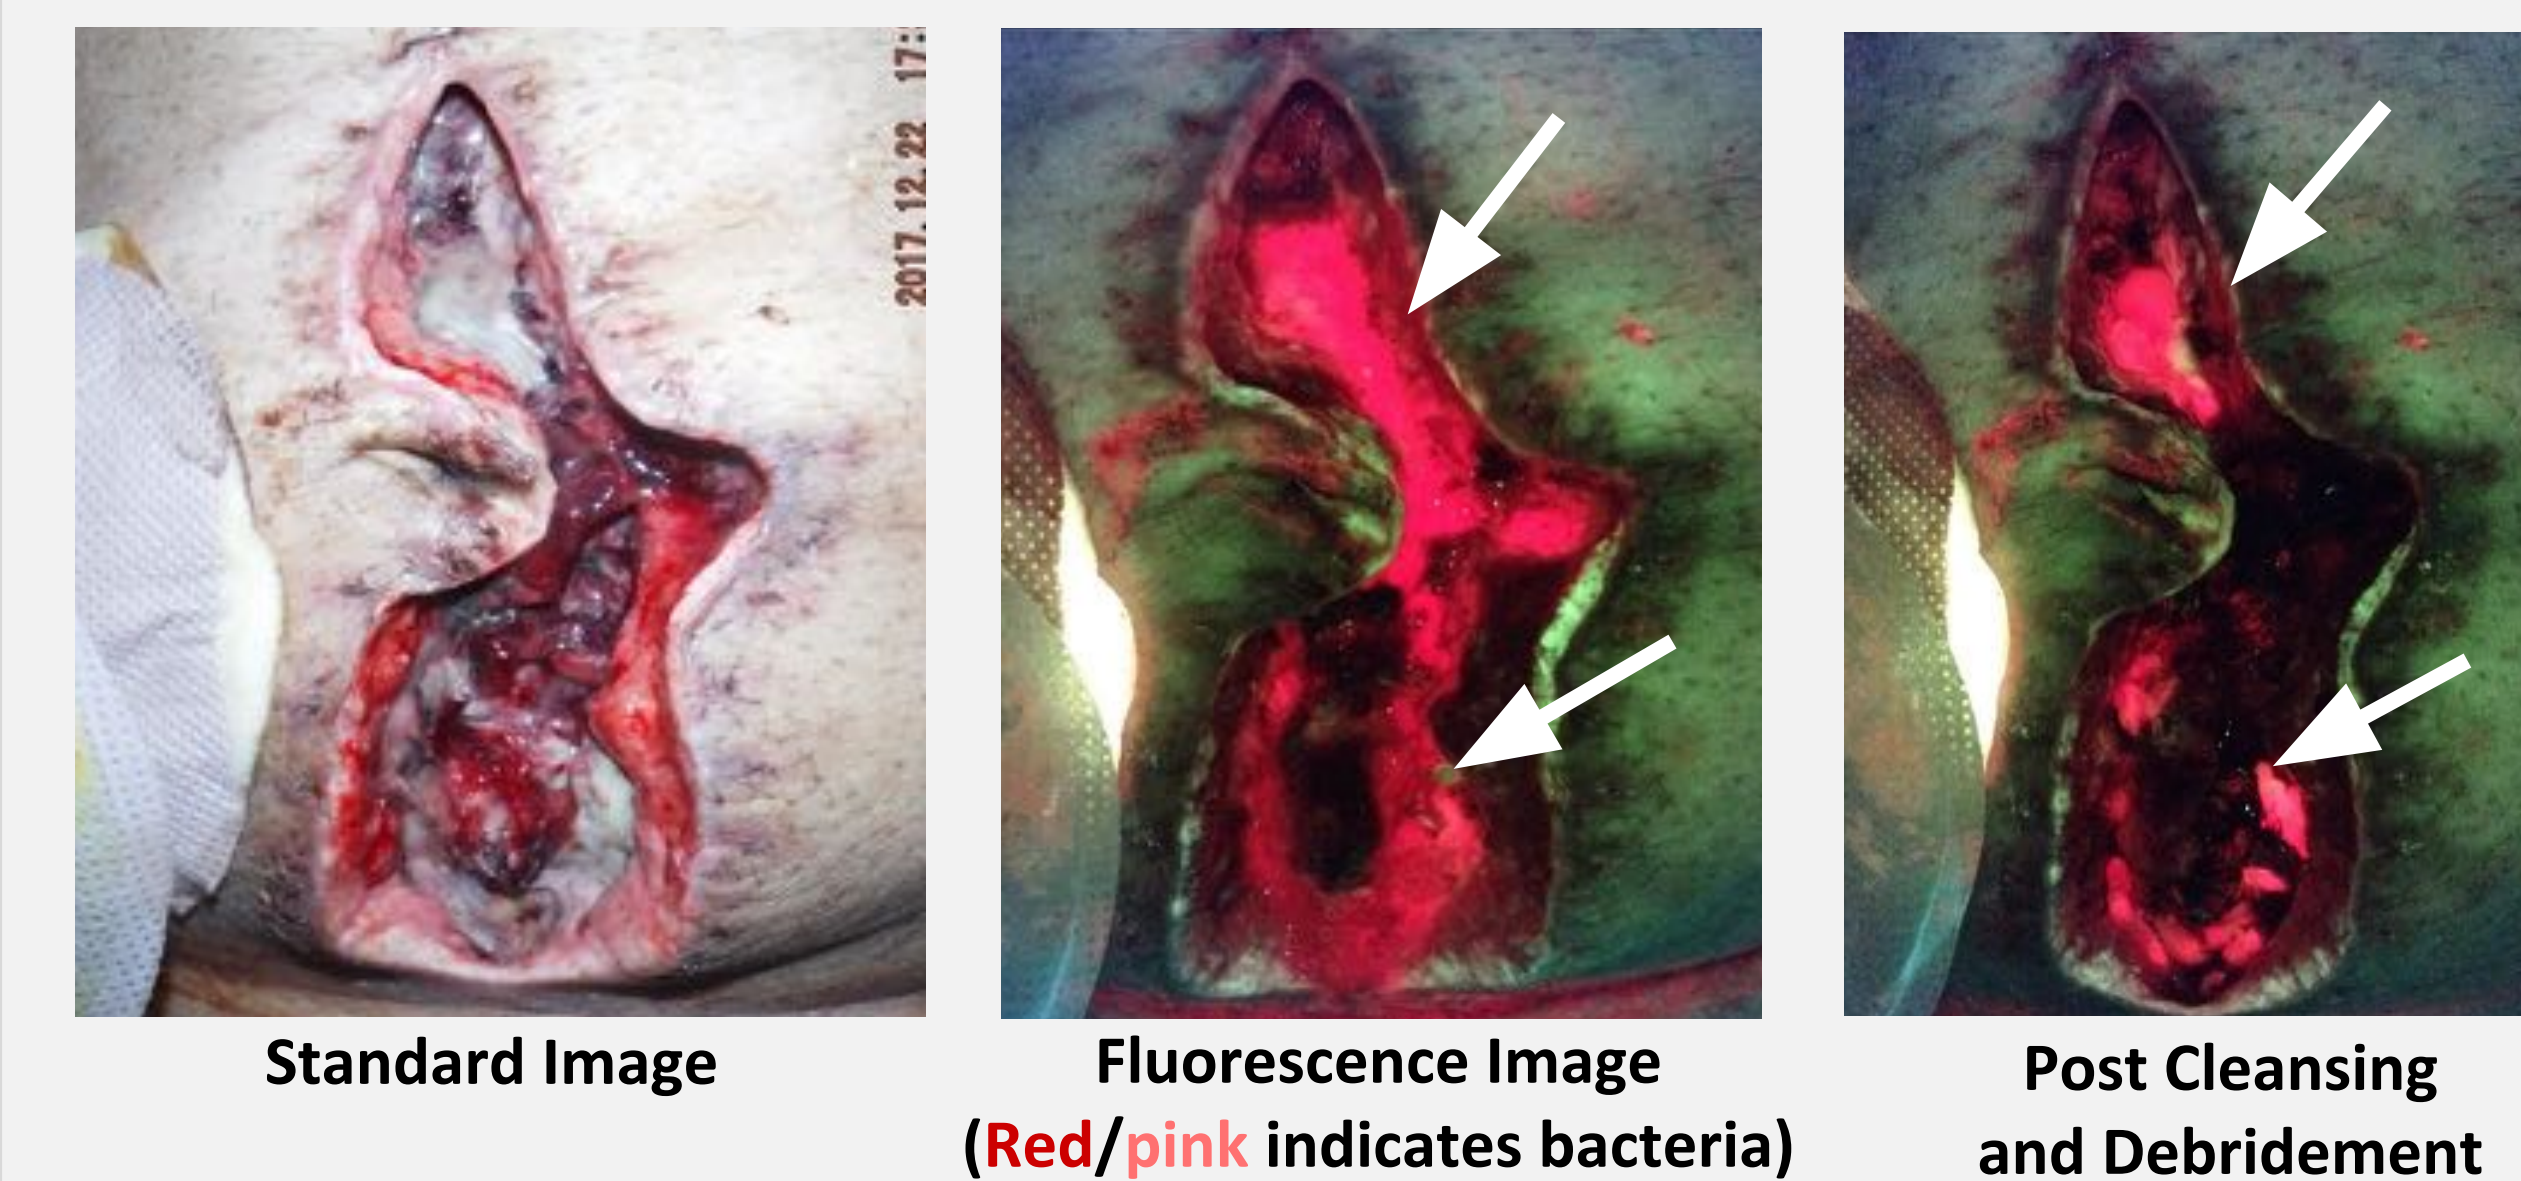
Case 4: Midline Abdominal Incision Line - Infection

Following a right hemicolectomy for an obstructing right colon adenocarcinoma, a week later presented with an anastomotic leak and intra-abdominal sepsis. Following Laparotomy and abdominal washout and creation of an ileostomy, he later presented with a dehiscd infected midline incision. Imaging represented following removal of NPWT, then wound hygiene.

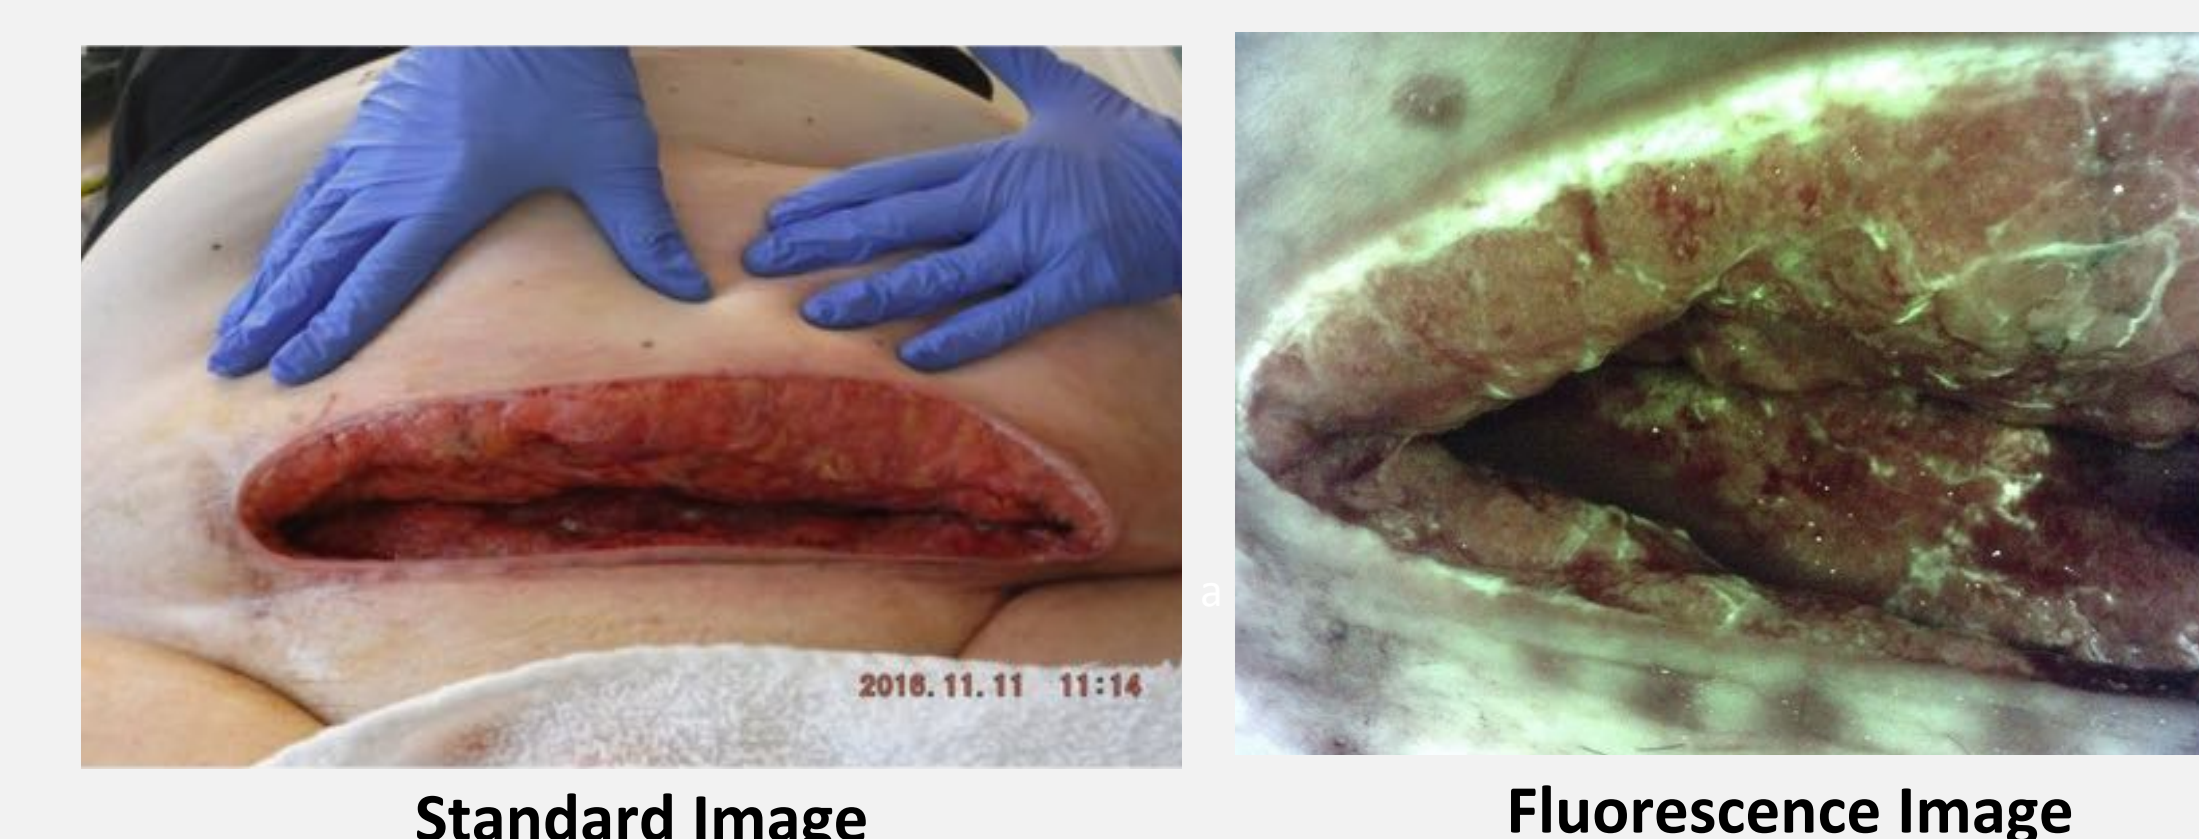
Case 5: Surgical Site Infection Abdomen

Patient: 60 year old female developed a post surgical site infection after a Total Abdominal Hysterectomy for a large uterine fibroid. Surgical Debridement and washout, with NPWT followed. At first dressing change patient was exceedingly anxious and looked for reassurance that her infection was "gone". Her wound received fluorescence imaging and then the photos were revealed to her which offered reassurance in terms of bacterial burden. This occurred at each dressing change – she stated "I no longer need ativan, as long as you use your wound tool – I am reassured."

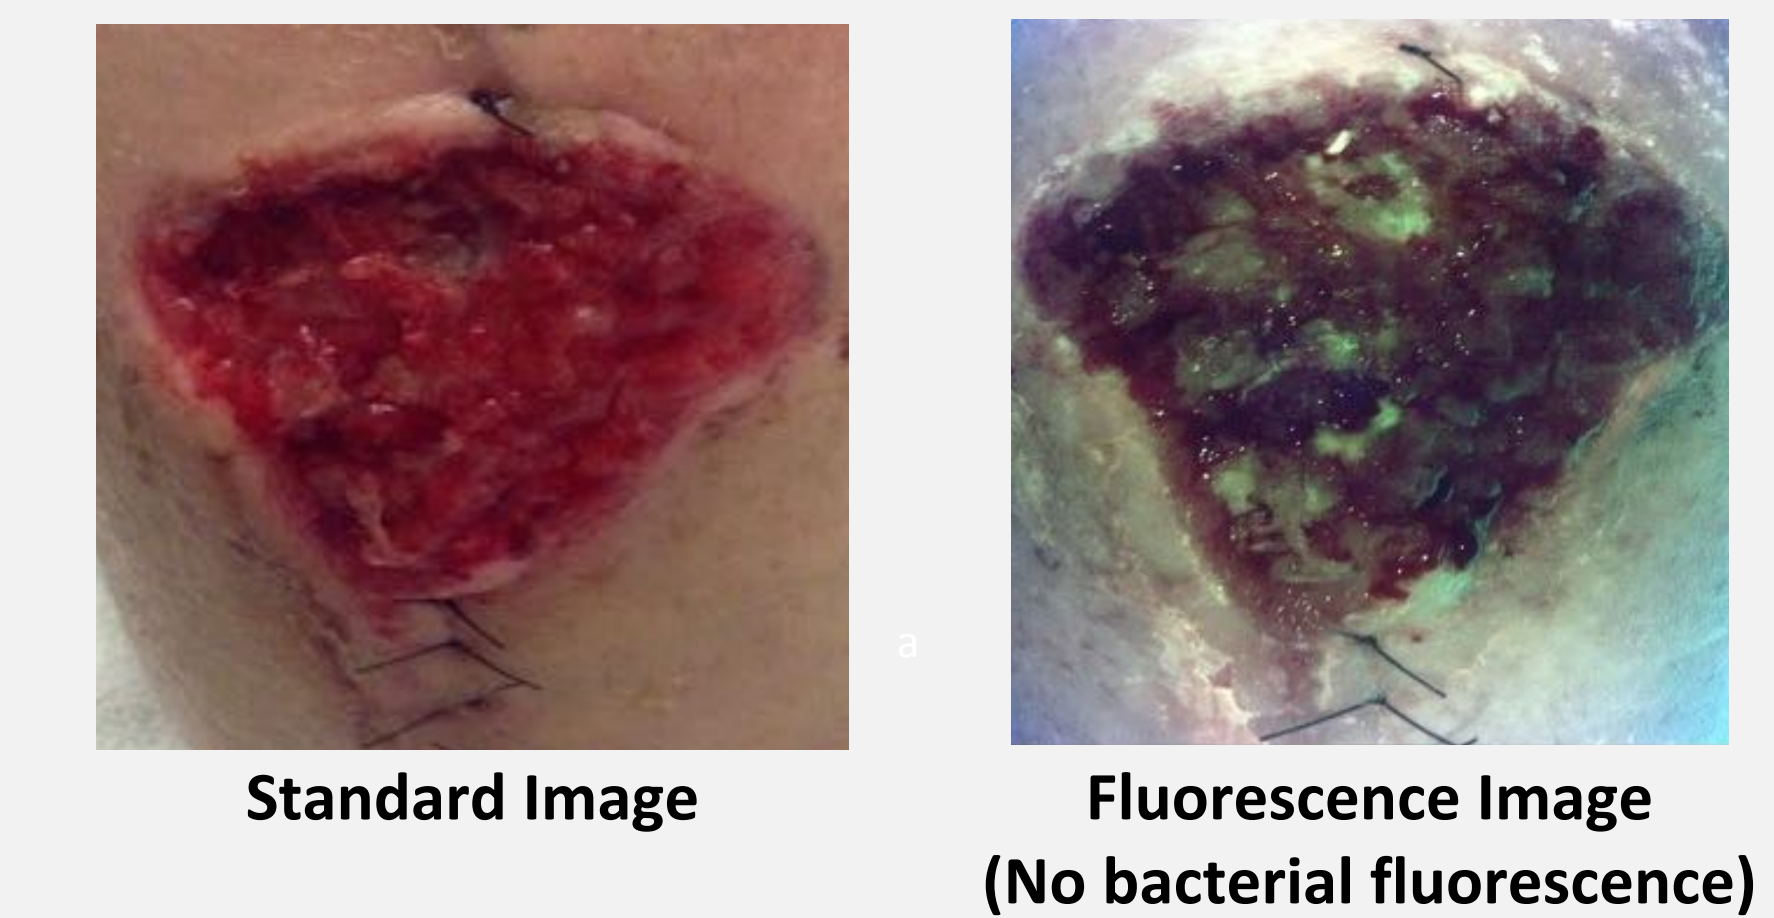
Case 6: Skin Graft

Fluorescence images were negative for bacterial fluorescence and thus graft applied with confidence within 36 hours. Swabs confirmed "no growth" of bacteria
