Handheld real-time bacterial fluorescence imaging guides wound cleaning and facilitates patient education in pilonidal sinus wound care patients

Rose Raizman, RN-EC, MSc, MNurs, PHCNP, CETN

Scarborough Rouge Health System, Toronto, Canada

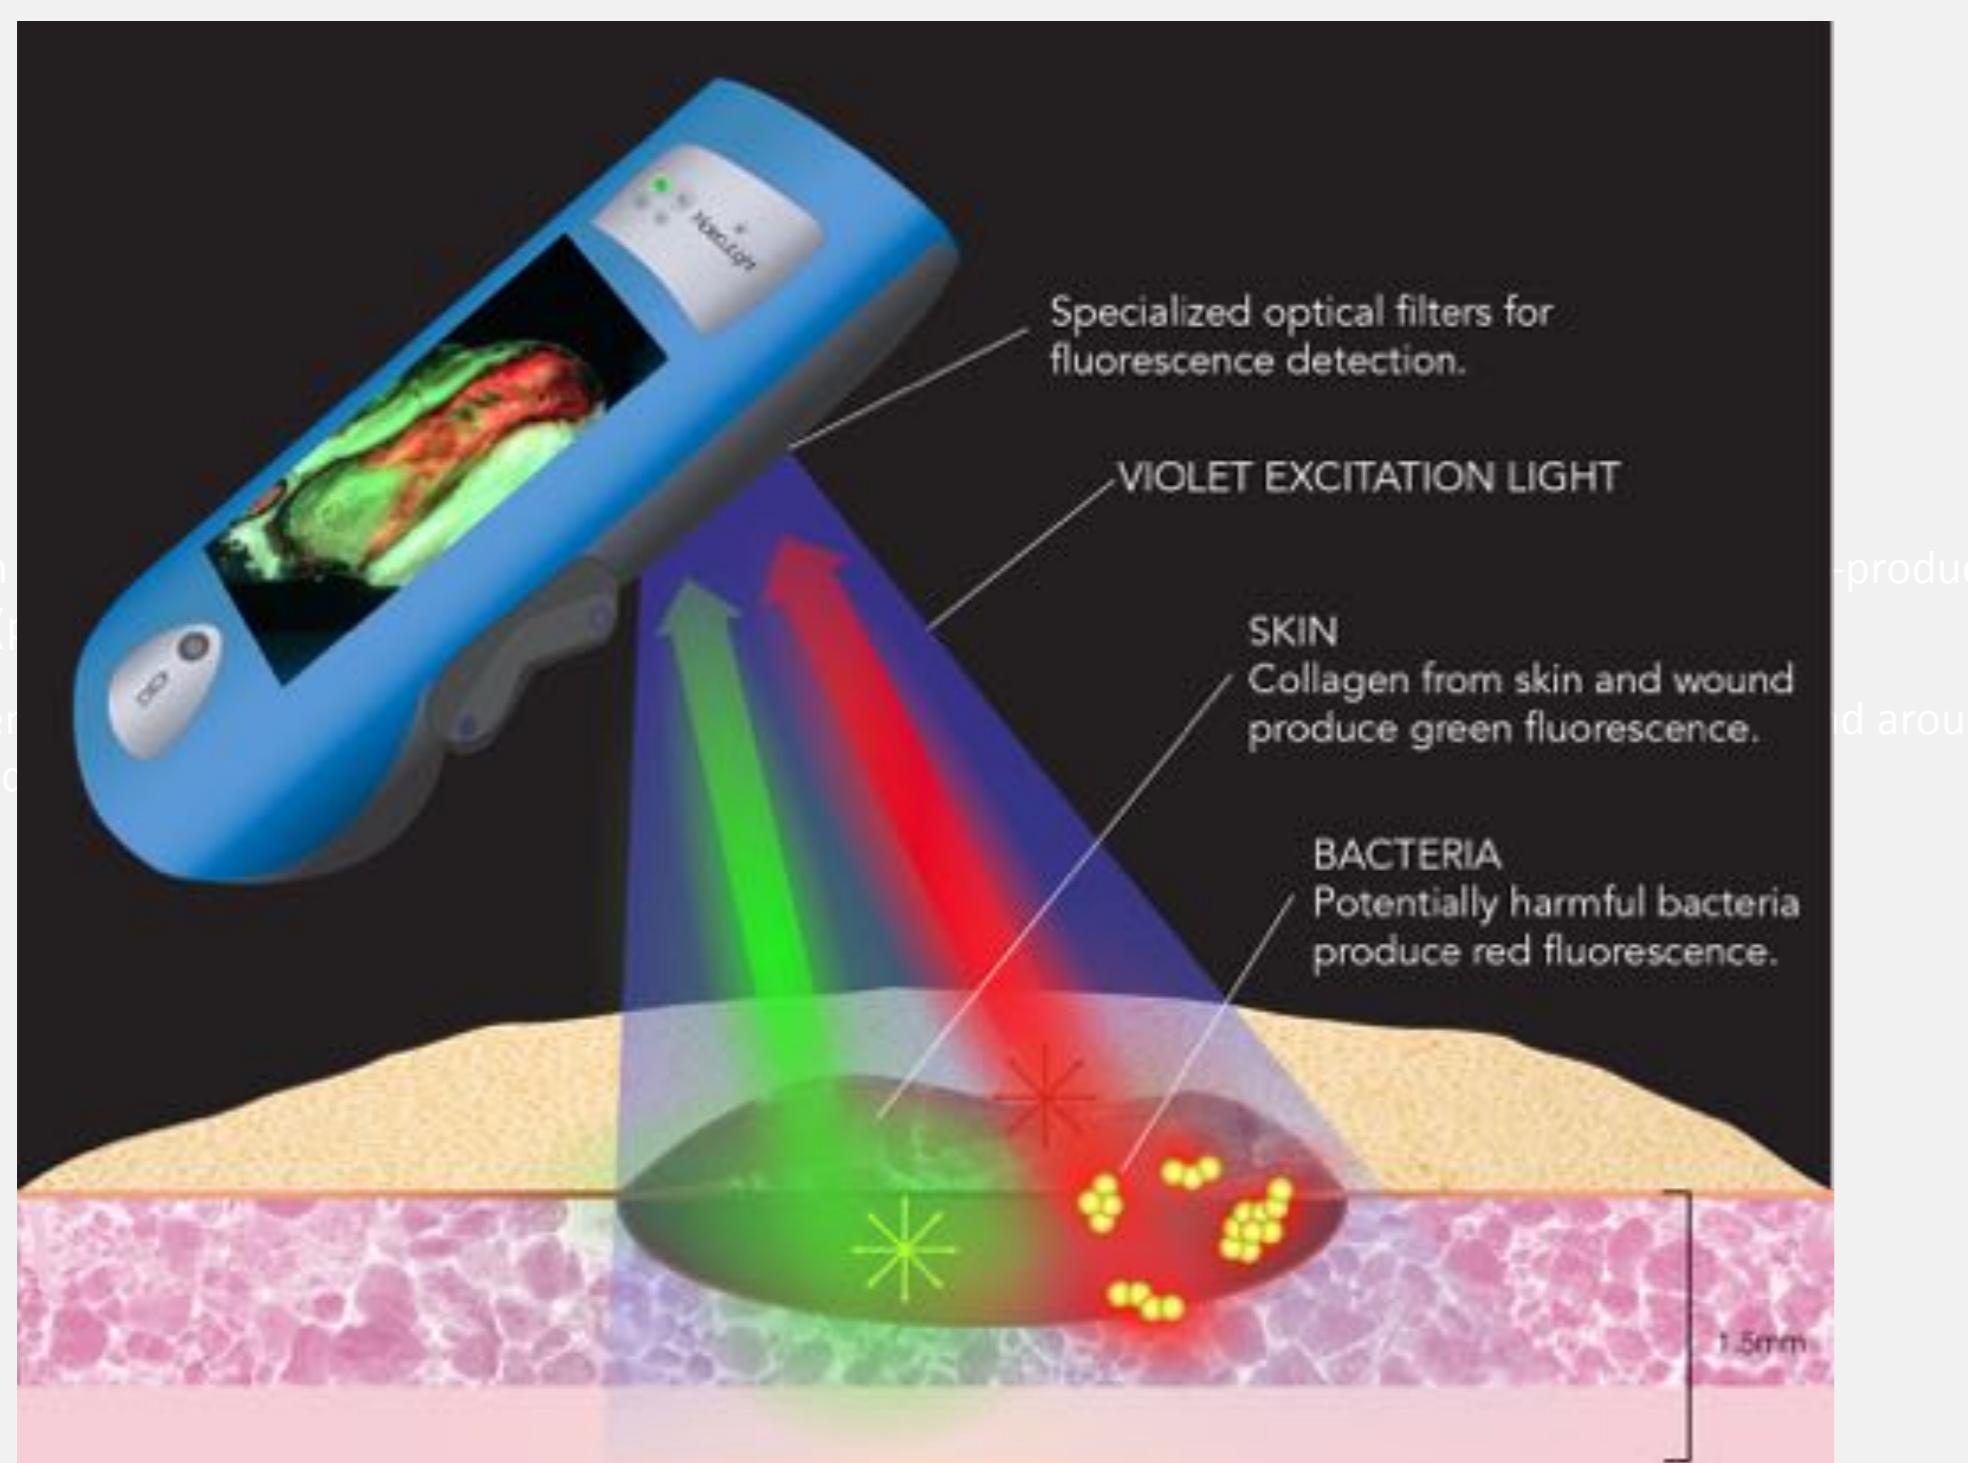
Bacterial Fluorescence Imaging

- When excited by 405 nm violet light, tissues fluoresce **green** while bacteria fluoresce **red**.
- This enables real-time, point-of-care detection and localization of bioburden ($\geq 10^4$ CFU/g) within and around wounds^{2,3}.

Pilonidal sinus patients (n=9) were imaged pre- and post wound cleaning during routine wound care to monitor the presence of bacteria, guide wound cleaning, and educate patients on home care cleaning practices.

Pilonidal sinus wounds that fluoresced red (7 of 9 patients) were considered positive for bacteria and received additional cleaning.

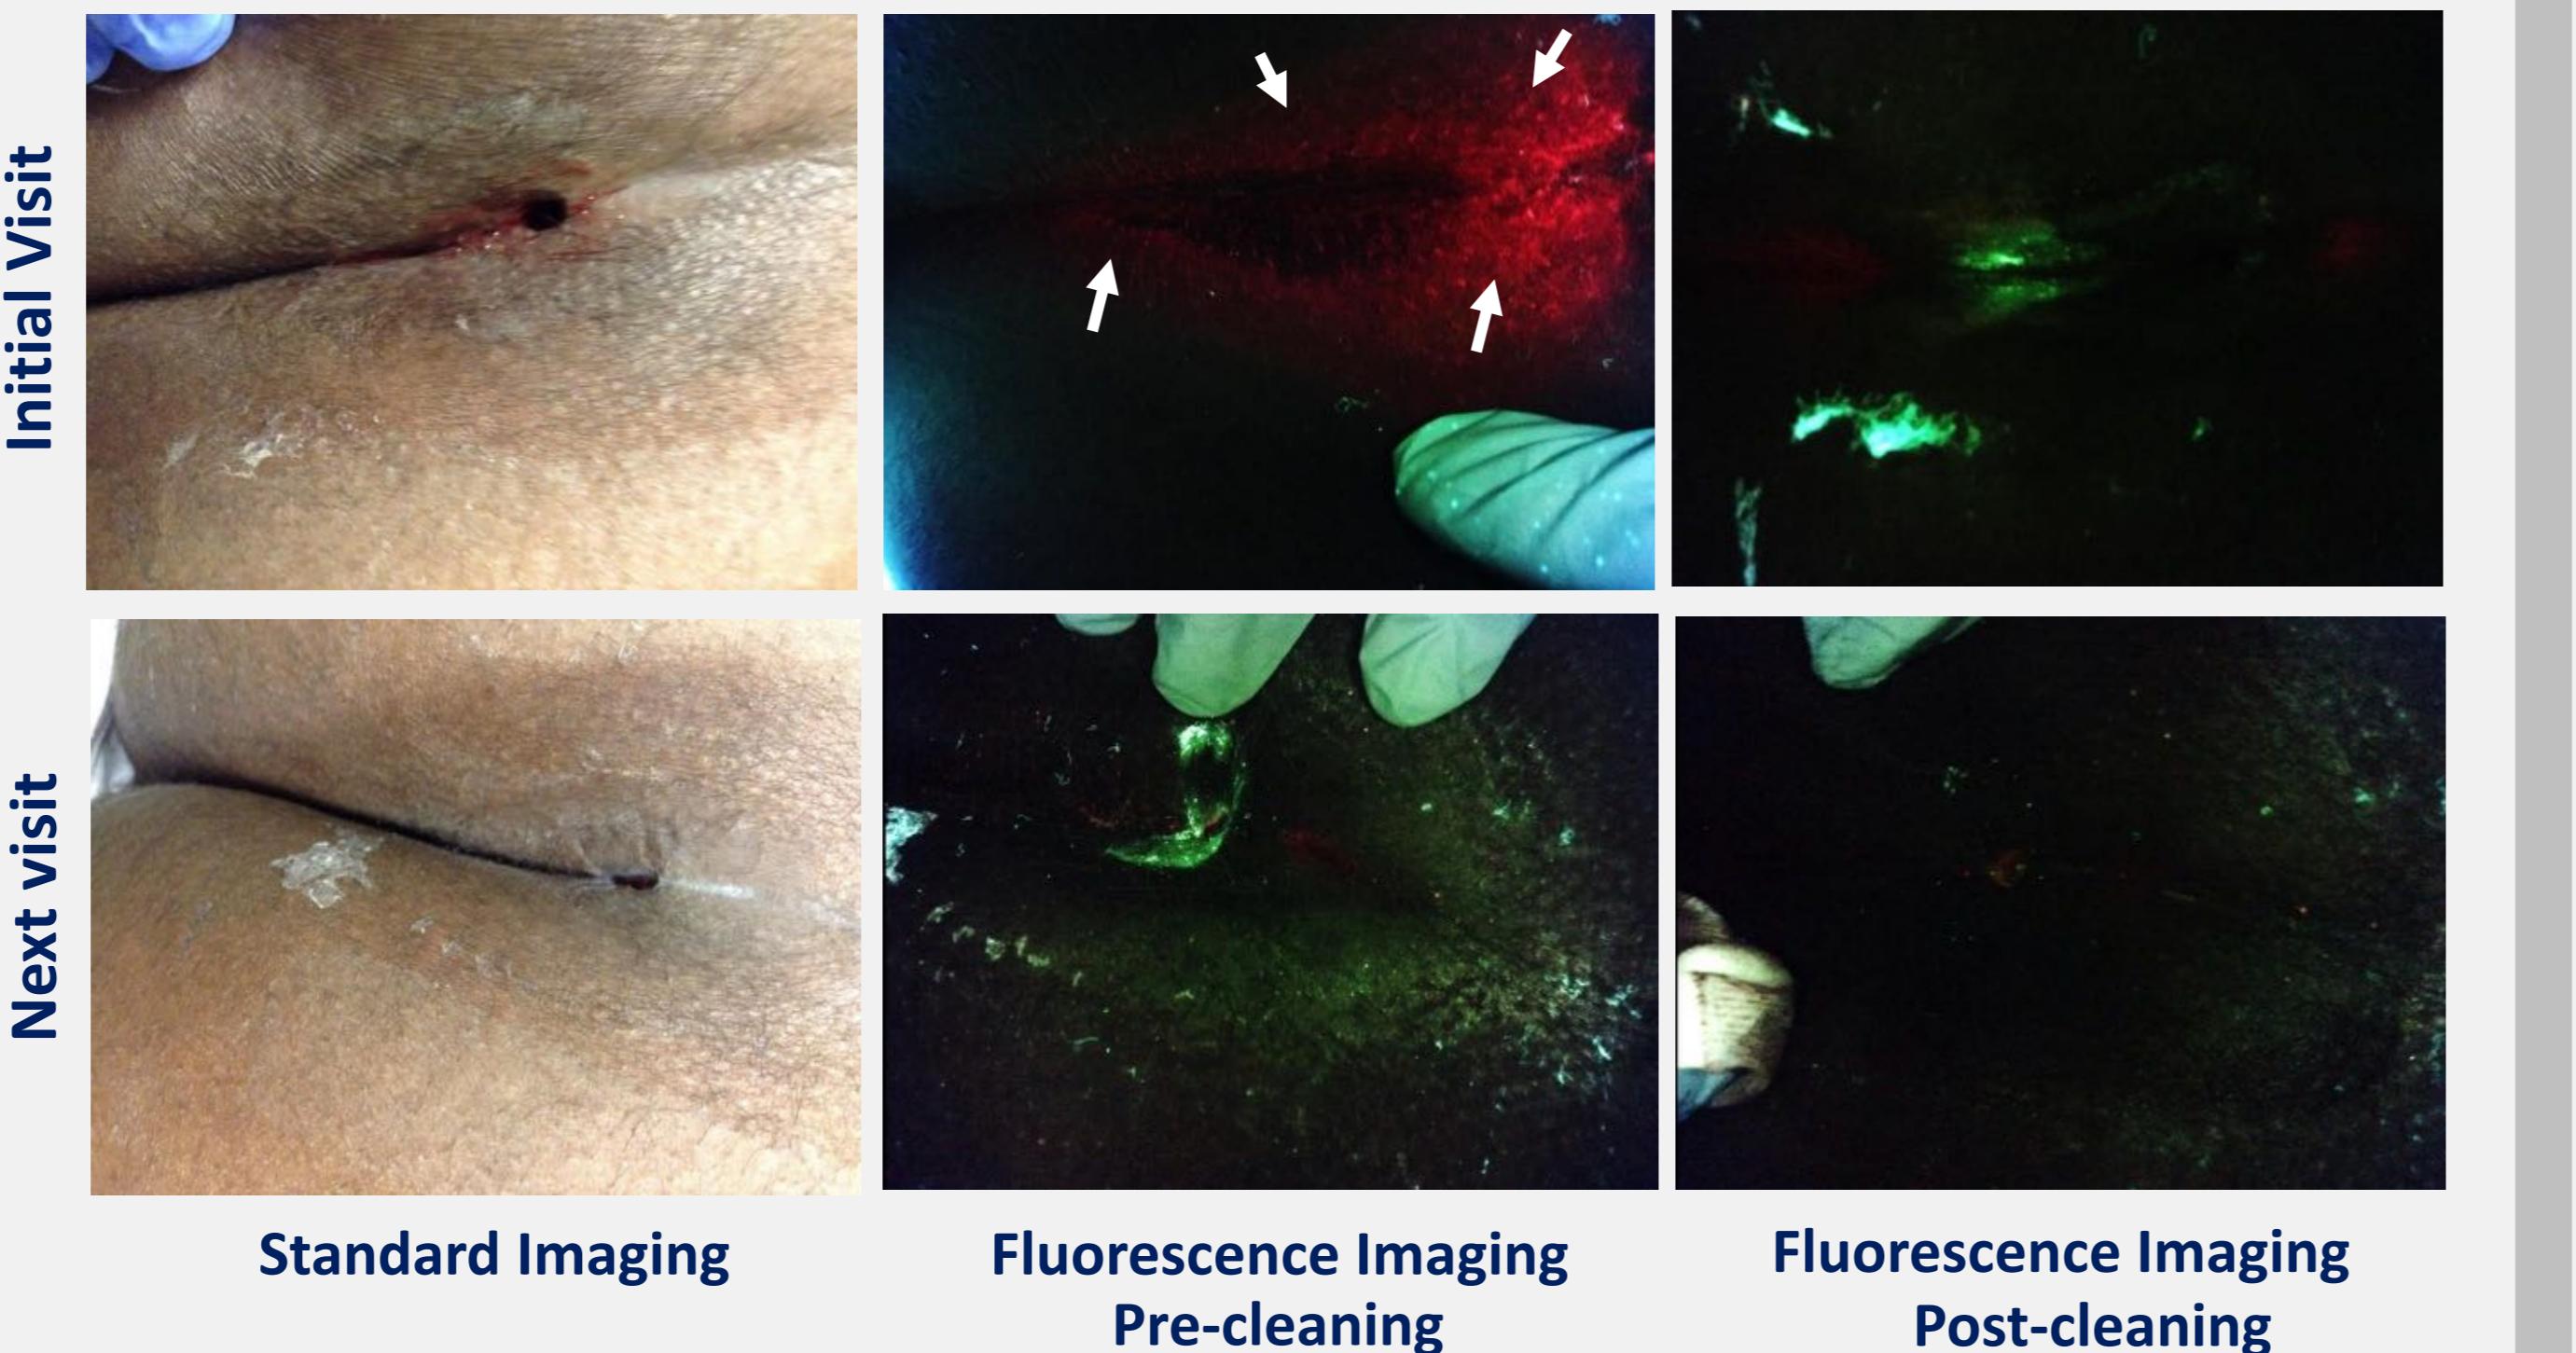
Images of Bacteria Improve Patient Understanding and Adherence to Wound Cleaning Regimes

Previously healed pilonidal sinus patient (15 year old female) presented with a re-opened surgical site. Red (bacterial) fluorescence was observed in the gluteal cleft. Images were used to educate the patient on bacterial presence and location and at-home cleaning practices that should be regularly performed.

One week later, bacterial fluorescence was no longer present, suggesting adherence to at-home wound care regime.

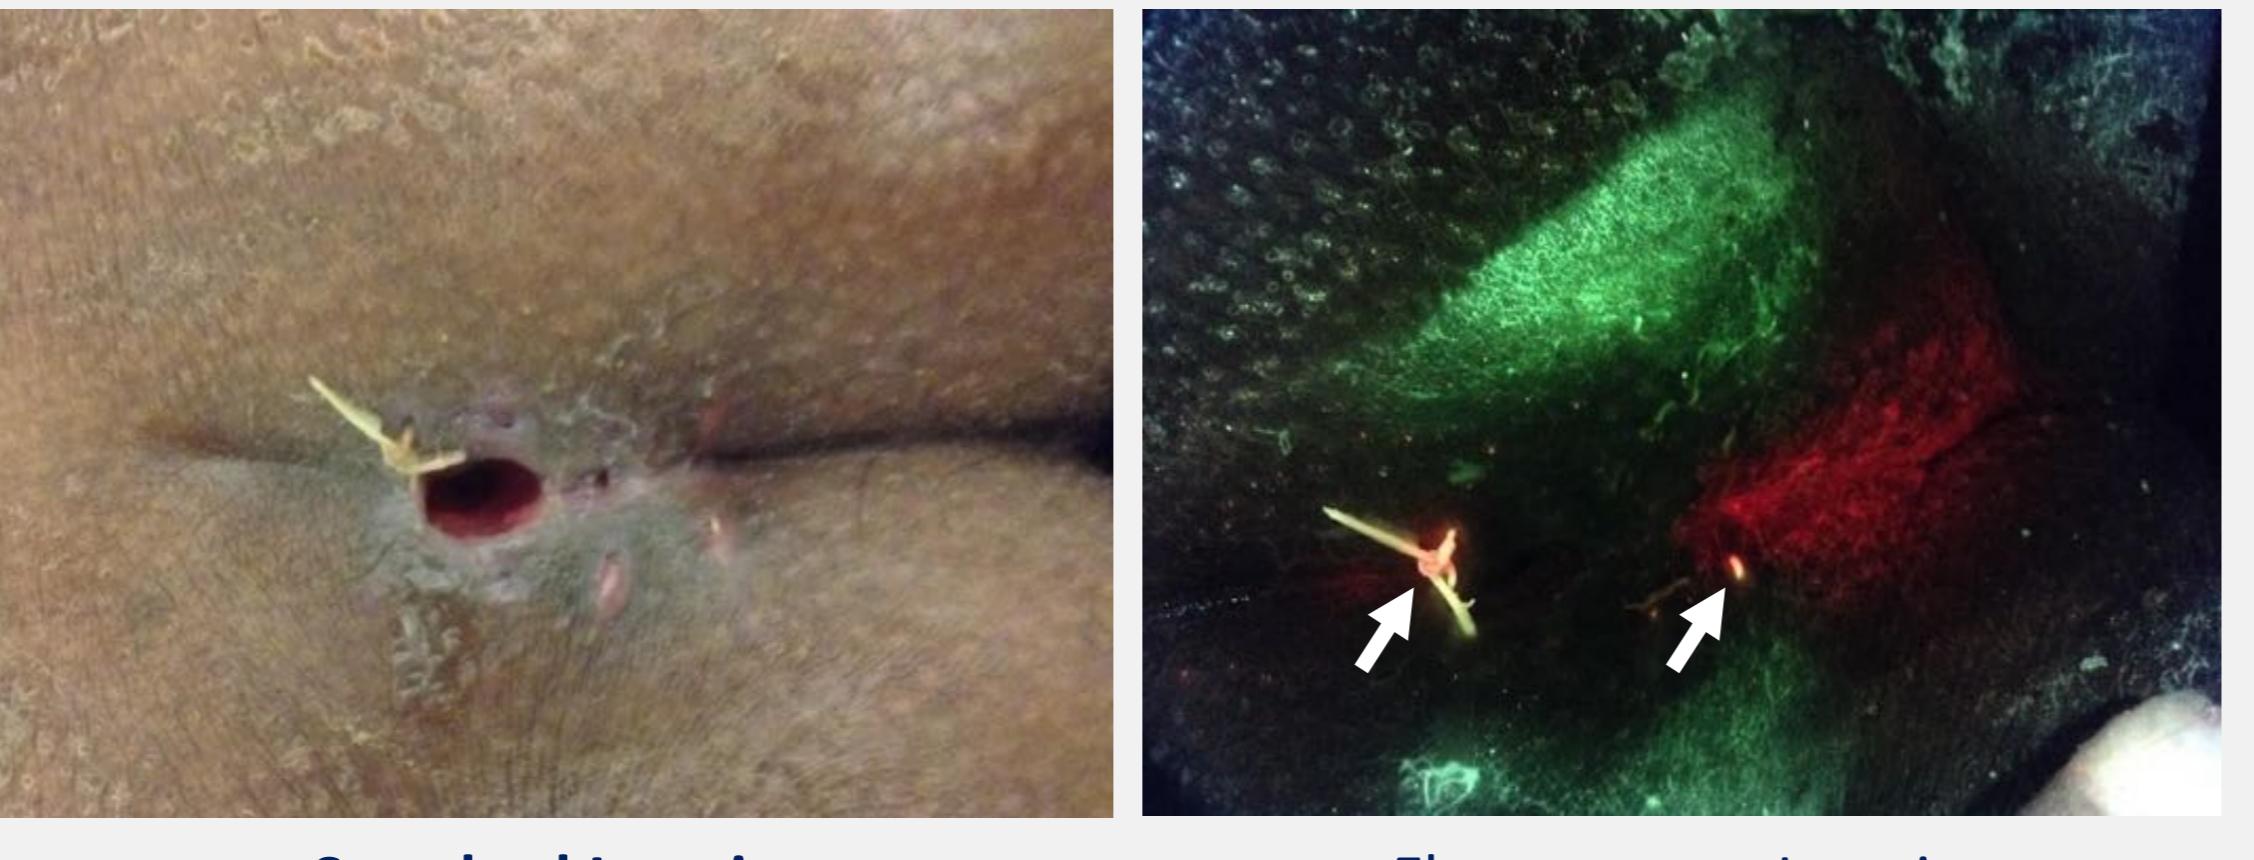
Detection of Contaminated Sutures Prompts Early Removal

Previously healed pilonidal sinus patient (25 year old female) presented with a re-infected surgical site. Red (bacterial) fluorescence was observed throughout the gluteal cleft. **Fluorescence guided cleaning of the wound revealed contaminated sutures, prompting their early, immediate removal.** Images were used to educate the patient on bacterial presence and location and at-home cleaning practices that should be regularly performed.

- Bacterial fluorescence images guided the extent and location of clinician cleaning and prompted an instance of early suture removal.
- Visualizing bacteria, which the patient otherwise could not have seen, provided enhanced awareness of their infection risk and facilitated patient education.
- Bright and simple colours (green = tissue, red = bacteria) on fluorescence images made it easy for patients to understand when and where bacteria was present. An improvement in patient adherence was observed.
- Results highlight the potential of this novel imaging device to guide clinician treatment in cases where bacterial contamination could impede wound healing and to improve patient understanding and adherence to home cleaning and hygiene protocols.

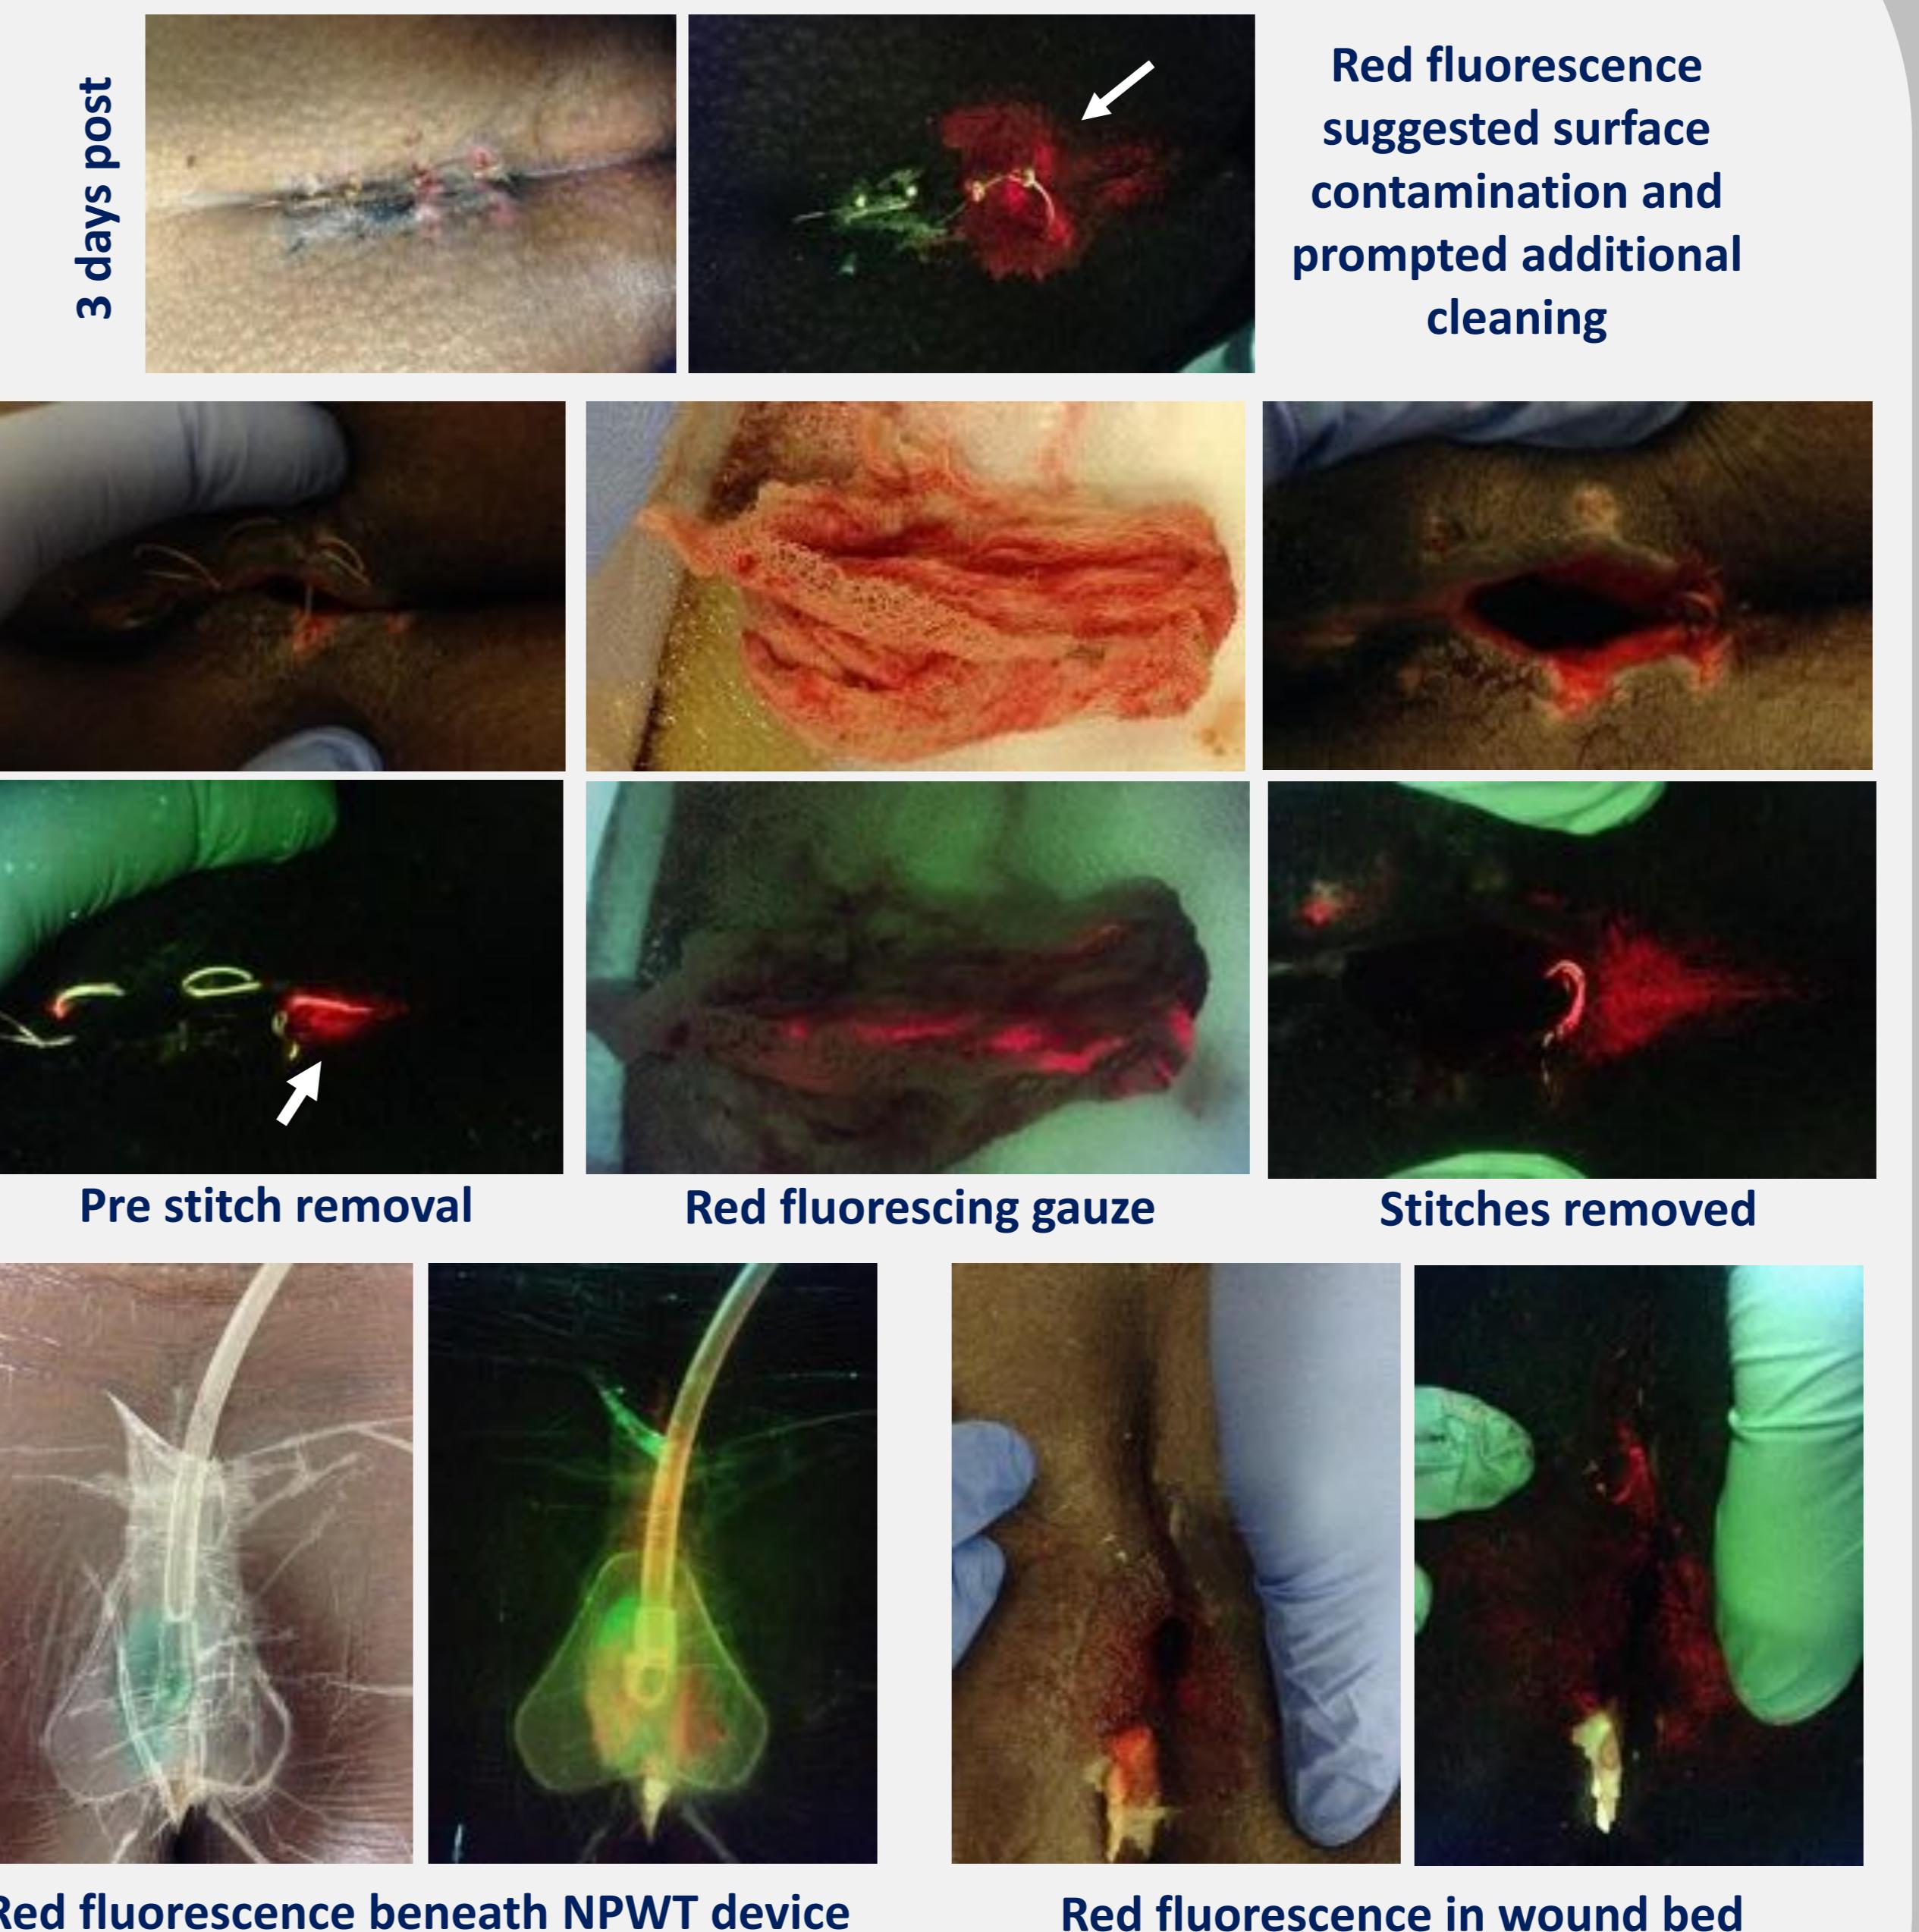
Bacterial Presence Monitored Throughout Post-Surgical Wound Healing

21 year old female with heavy bioburden monitored throughout healing process. Bioburden was visualized within wound bed, on gauze, and beneath NPWT device. Swabs confirmed heavy growth of *B. fragilis*, *M. morganii*, *S. agalactiae*

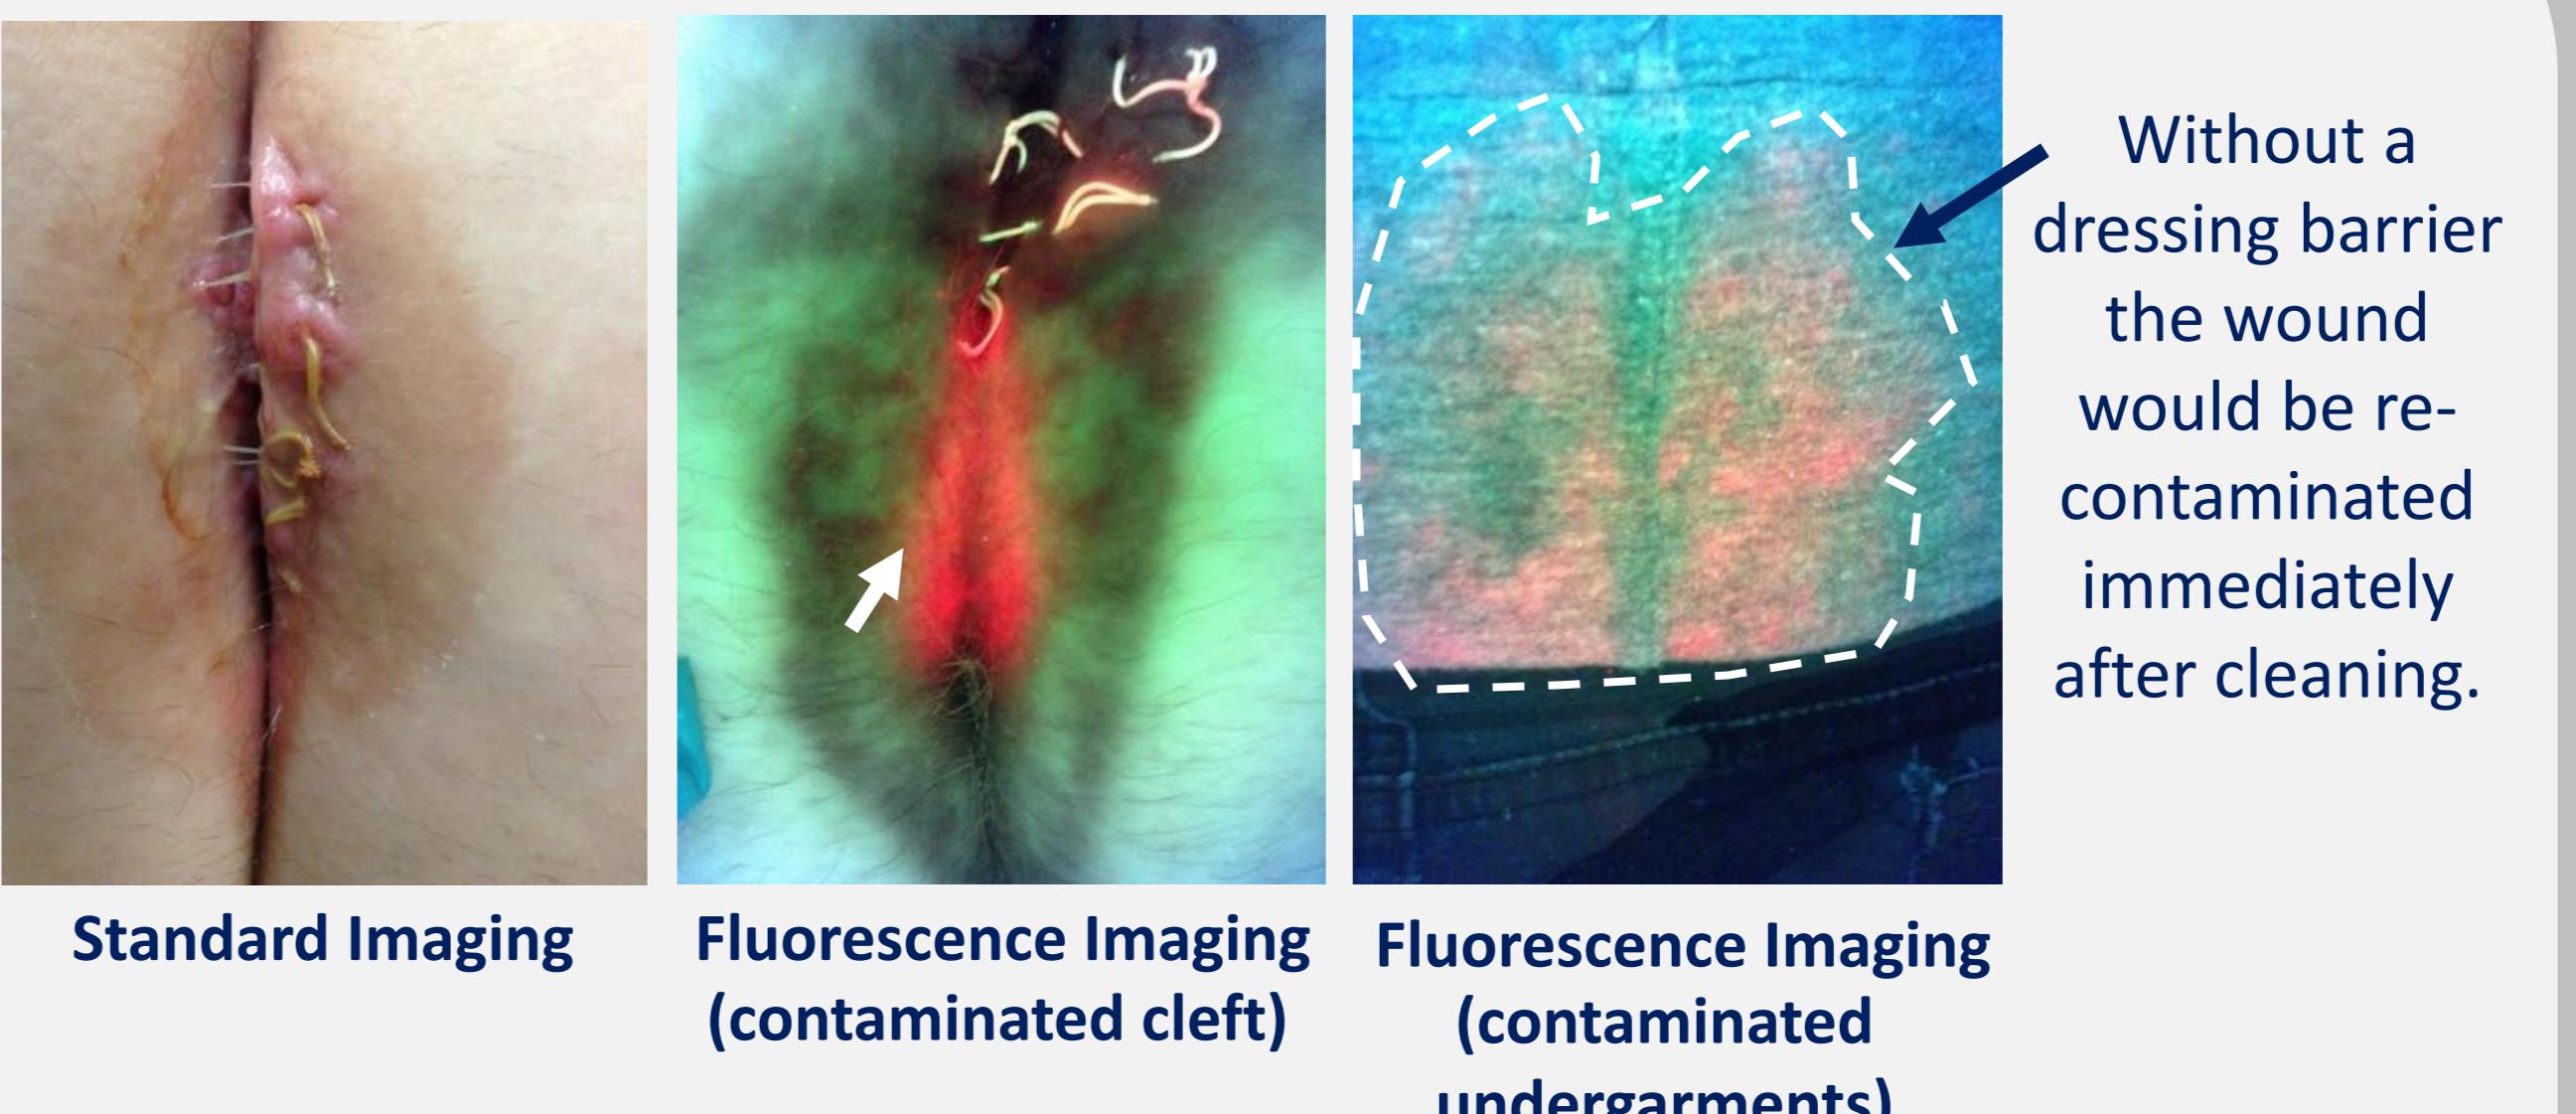
Bacterial Contaminated Wound & Undergarments

Images guided patient (45 y.o. male) education on the presence of bacteria (red in images) to raise awareness about infection and hygiene.

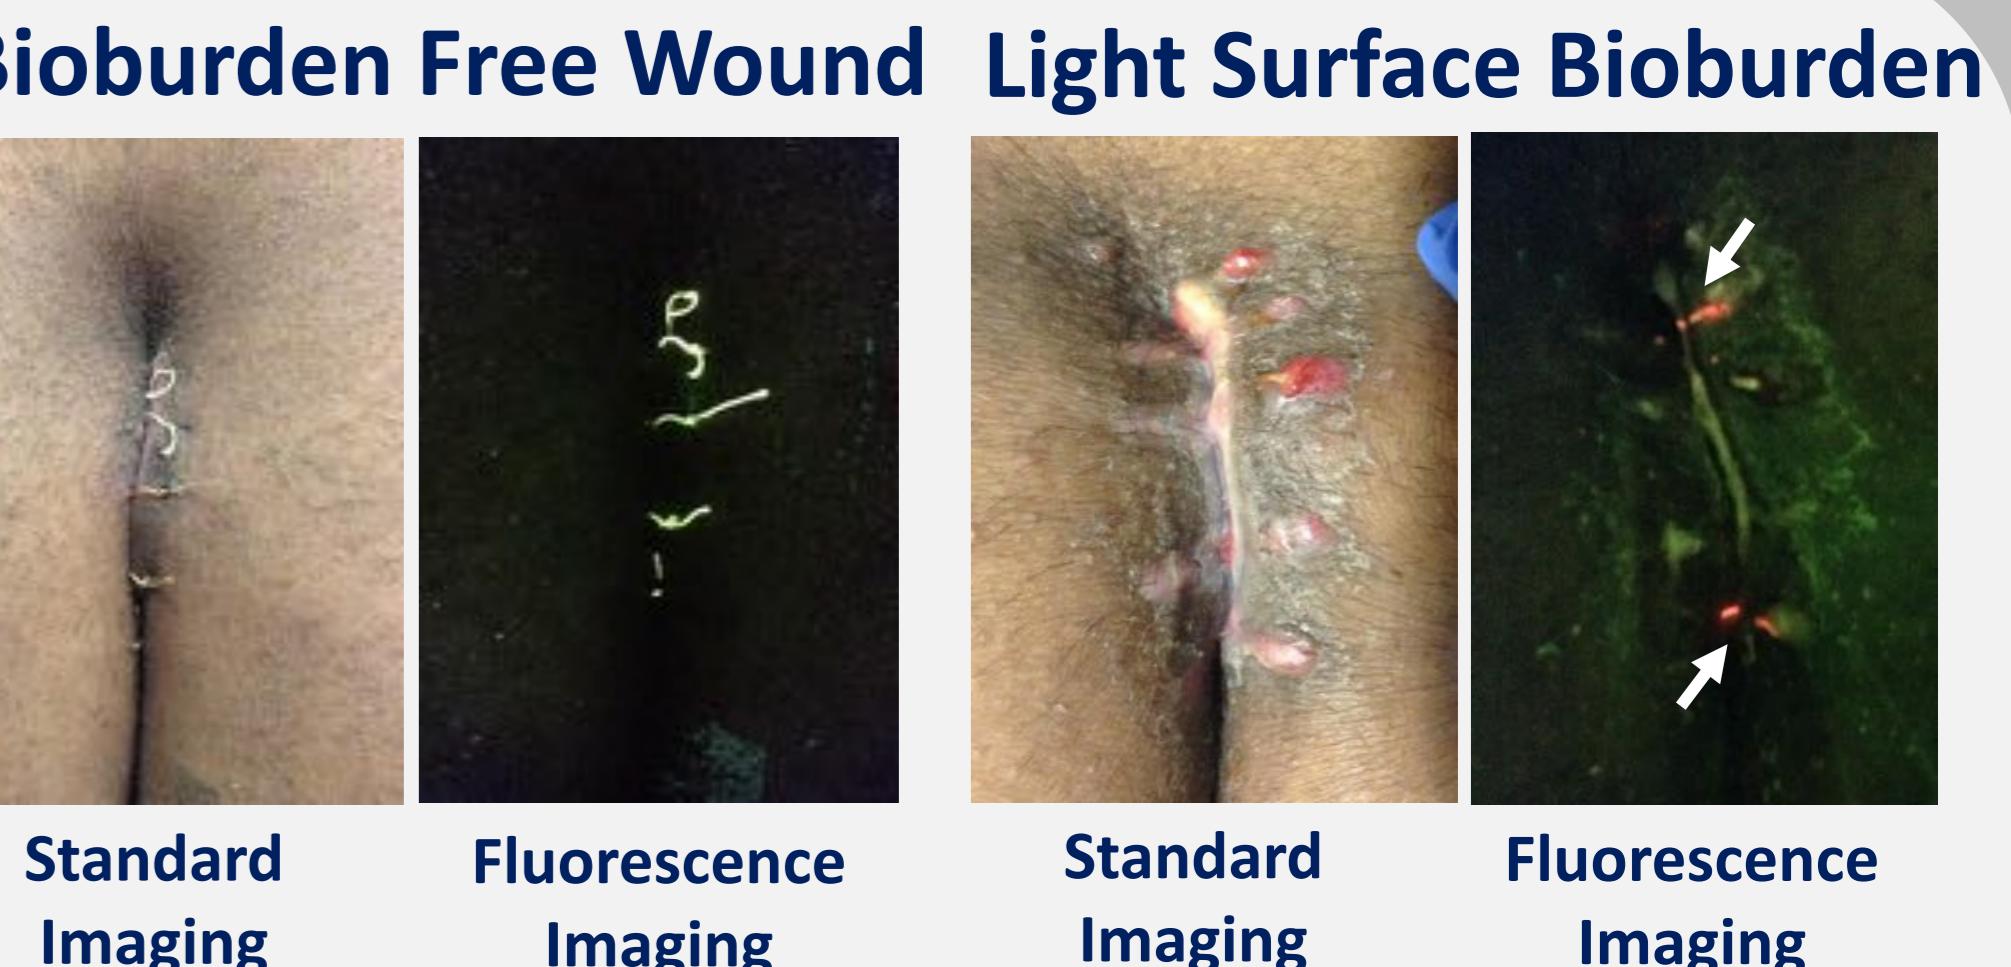
Real-time visualization of wounds with no or light bioburden helped the clinician to determine (1) the effectiveness of treatment regime (including selected antimicrobial dressings) and (2) home care and patient adherence to wound cleaning protocols.
