# Point-of-care fluorescence imaging device guides wound cleaning and patient education in obese wound care patients

Rose Raizman, RN-EC, MSc

Scarborough & Rouge Hospital, Toronto, ON, Canada

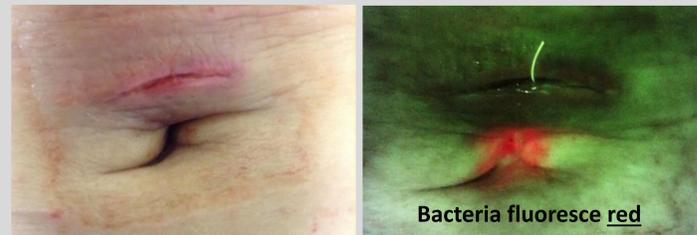
### Real-time Bacterial Detection in Abdominal SSI Enables Guided Cleaning of Red Fluorescing Regions

Wound dehiscence after minor abdominal surgery in 36 year old male with no significant medical history. Red fluorescence was observed near the wound, suggesting bacterial contamination and prompting clinician cleaning of this region.

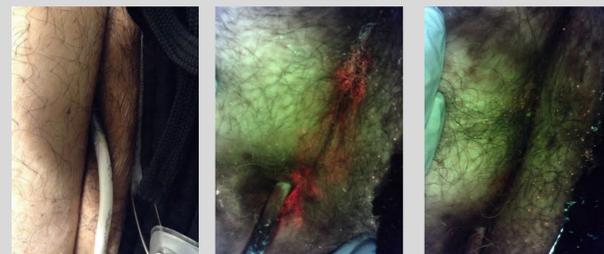
#### Week One

26 year old moderately obese male with abdominal drain for infected tumour abscess. Bacterial (red) fluorescence was observed throughout the skin fold/crease. Fluorescence guided cleaning with water did not remove the fluorescing bacteria, thus iodine was used. Post cleaning images show the decrease in red fluorescence. Images were used to educate patient on at home cleaning practices. Images acquired three weeks later showing no bacterial (red) fluorescence demonstrated effectiveness of patient education and cleaning.

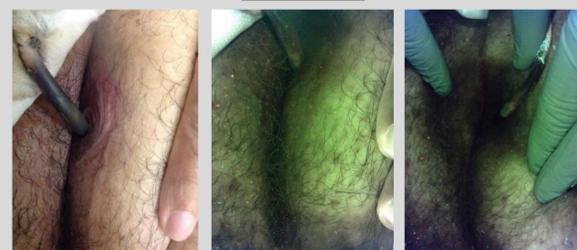
#### Week Three

Fluorescence Imaging (no red observed)

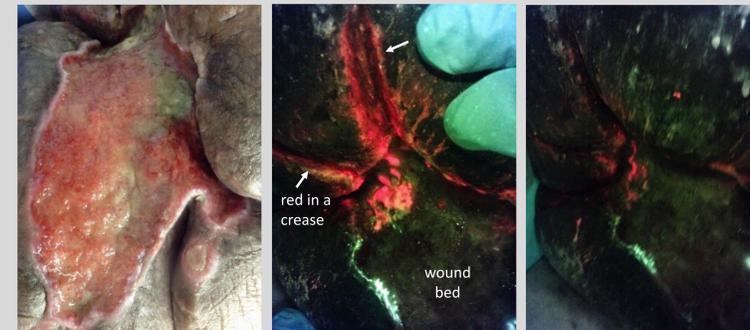
### Cleaning of Skin Folds Under Bacterial Fluorescence Guidance Increases Wound Healing Rates and Patient Compliance in a Non-Healing, Lymphedema Complicated VLU

Morbid obesity-associated lymphedema in this 56 year old female patient resulted in extreme leg swelling and a non-healing venous leg ulcer. Deep skin creases surrounding the wound provide an environment in which bacteria can thrive, but the patient would not tolerate crease cleaning due to extreme pain. Images demonstrating widespread bacterial (red) fluorescence in the creases were used to educate the patient, resulting in increased tolerance for crease cleaning, both at wound care visits and at home. With regular crease cleaning the wound began to decrease in size and was reclassified as "healable".

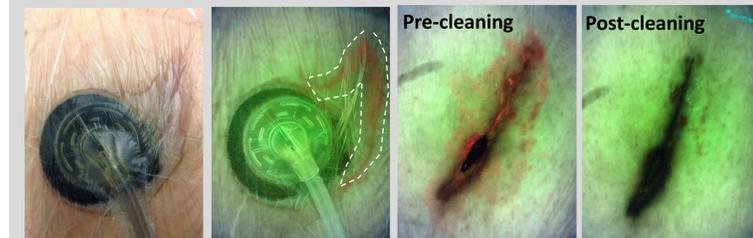
### Bacterial Fluorescence Images Guide Extent and Location of Wound Cleaning at Scheduled NPWT Dressing Change in Obese Patient with Abdominal Wound

58-year-old moderately obese male with appendectomy abscess undergoing negative pressure wound therapy. Red (bacterial) fluorescence observed under adhesive (circled) and on wound. Red fluorescence guided the extent and location of wound cleaning at this dressing change.
