Documentation of wound surface area and fluorescence bacteria characteristics using a point-of-care, hand-held imaging device

Rose Raizman, RN-EC, MSc
Scarborough Rouge Hospital System, Toronto, ON, Canada

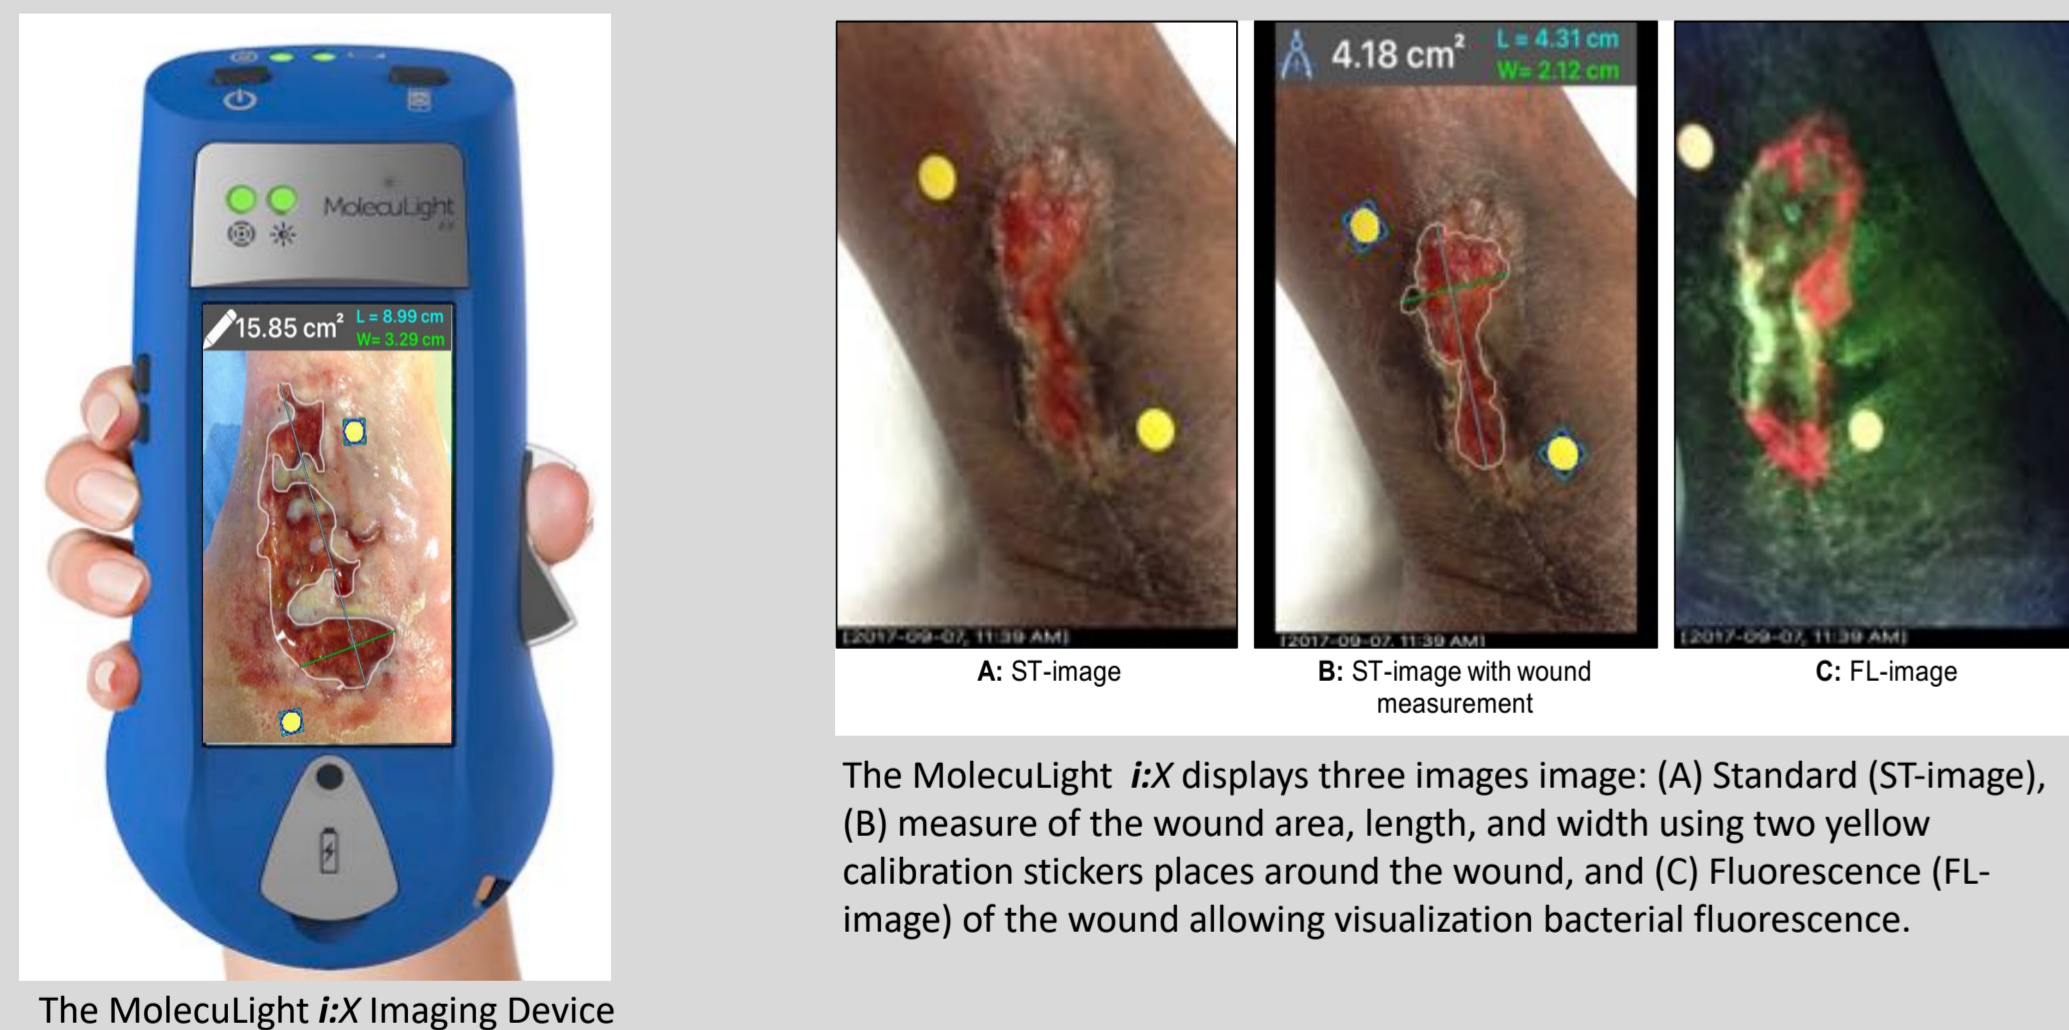
WOUND IMAGING

- 25 wounds were imaged using a non-contact, hand-held device at the point-of-care.
- Wound surface area was measured and documented for up to 6 months.
- Fluorescence imaging of the wounds was also performed to assess presence of bacteria using the same handheld imaging device³.

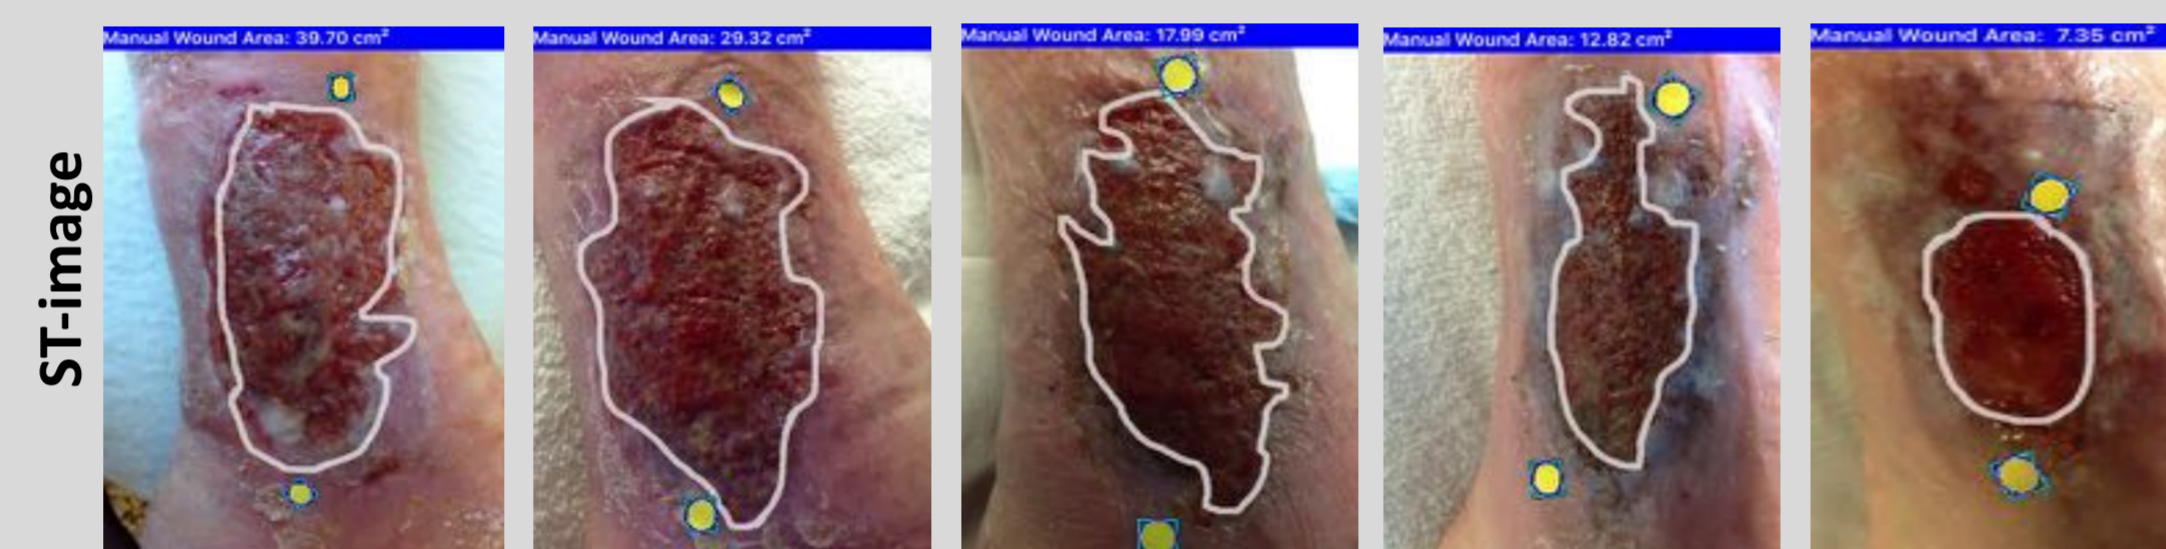
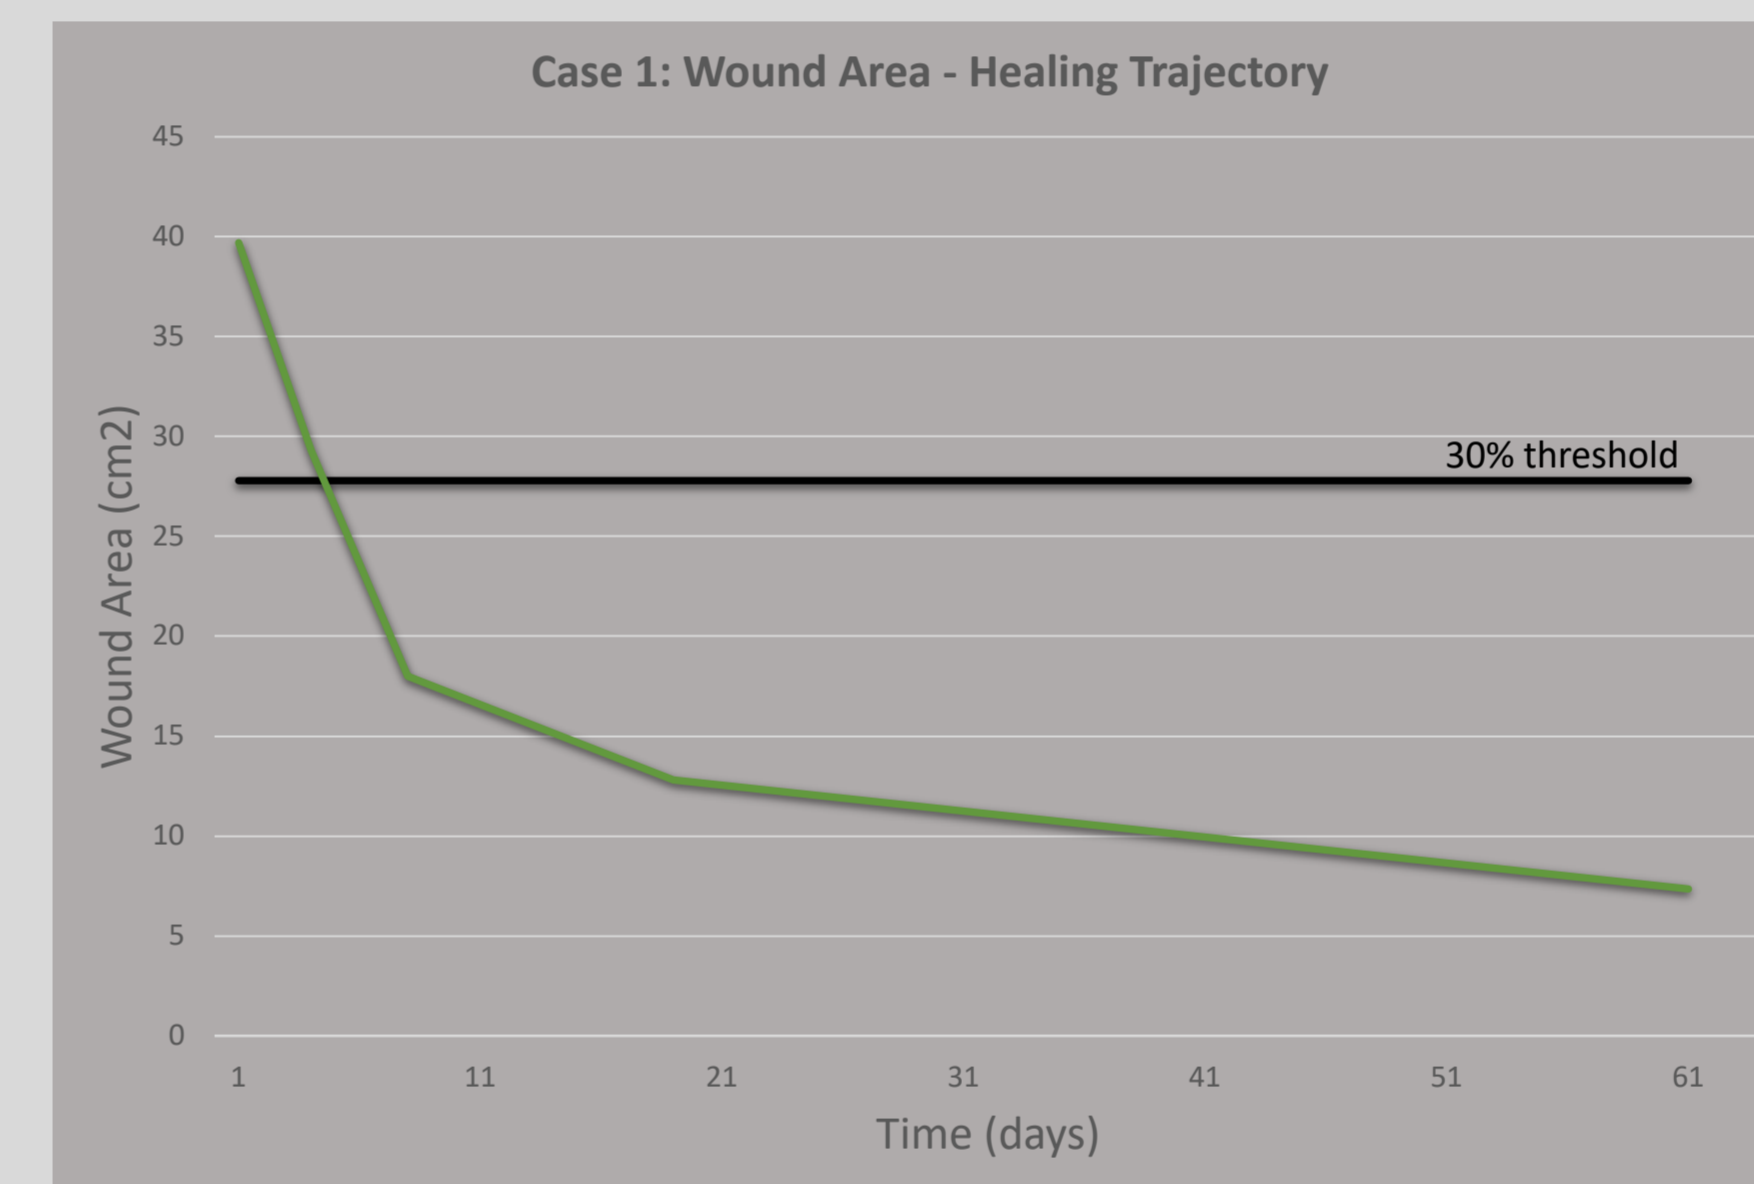
Case 1: Healing Trajectory

The care paradigm of this 72 year old venous leg ulcer patient included wound cleansing, sharp debridement, and compression dressing. The wound decreased in size by 30% in just 8 days, meaning that it was projected to progress through the continuum of healing without complication.

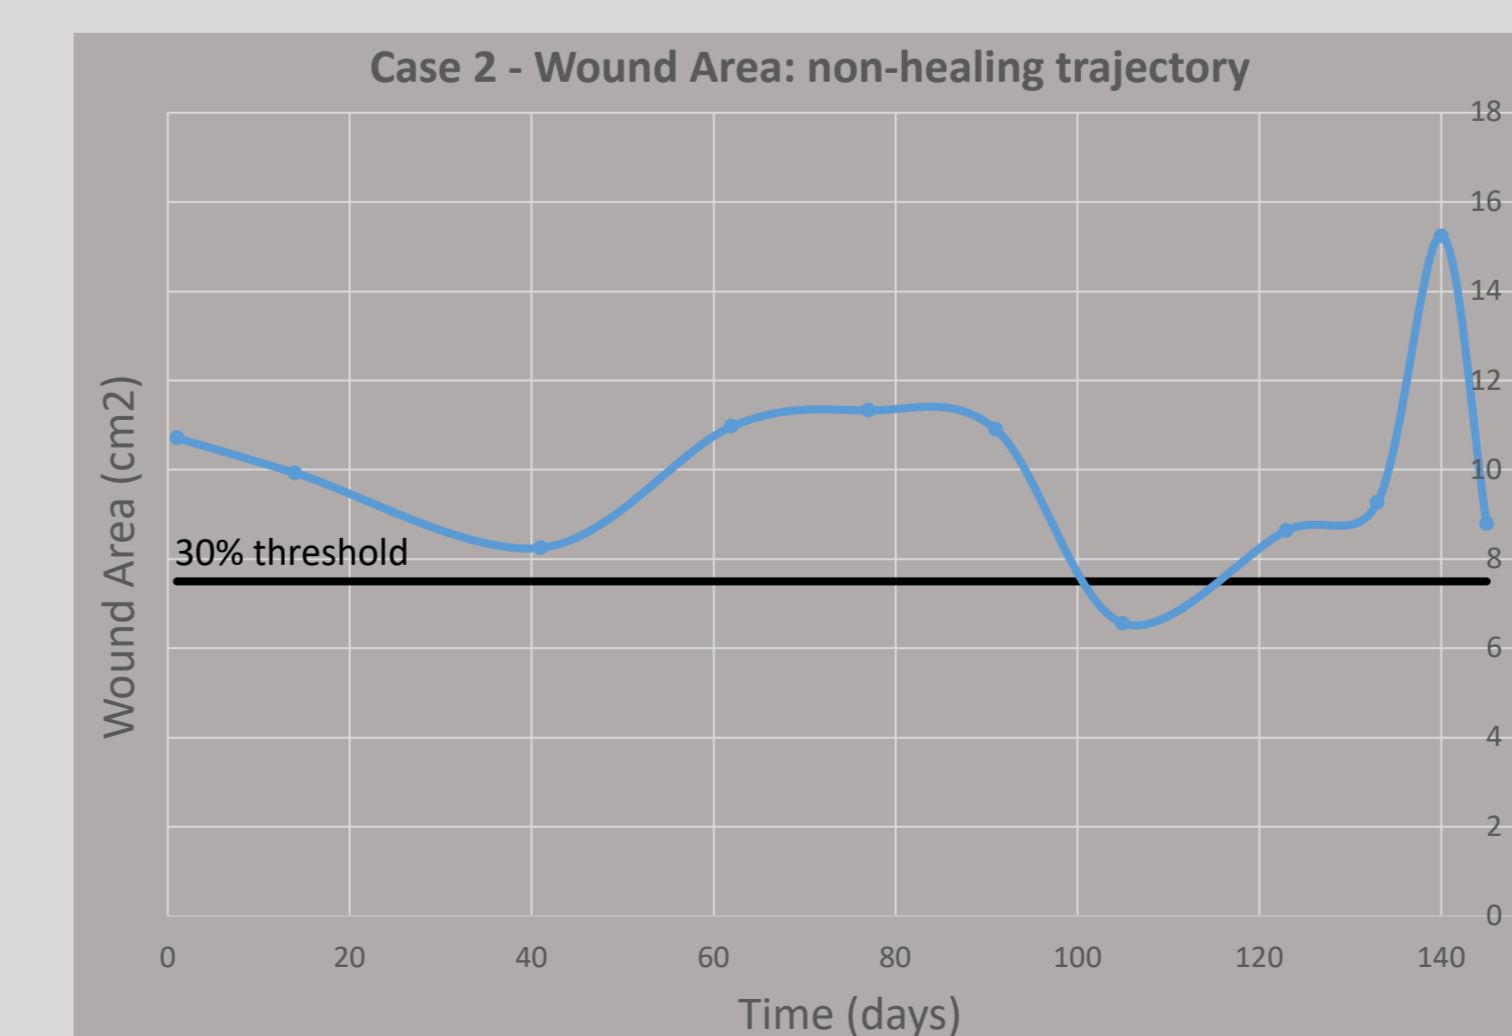
Case 2: Non-Healing Trajectory

The care paradigm for this 74 year old venous leg ulcer patient includes debridement, infection management with antimicrobial cleansing and compression bandages. The wound area failed to decrease by 30% in 4 weeks, and therefore the care paradigm was re-assessed. Tissue samples obtained at 91 and 140 days confirmed polymicrobial presence as indicated by the presence of red fluorescence in the FL-images.

The lack of progress of the wound between 62 – 91 day time points again prompted for a re-assessment of the care paradigm, one which rapidly decreased the size of the wound over a two week period.

The wound increased in size dramatically at 140 days, again prompting a change in care including sampling of microbiological load. The wound again experienced a steep decrease in wound area.

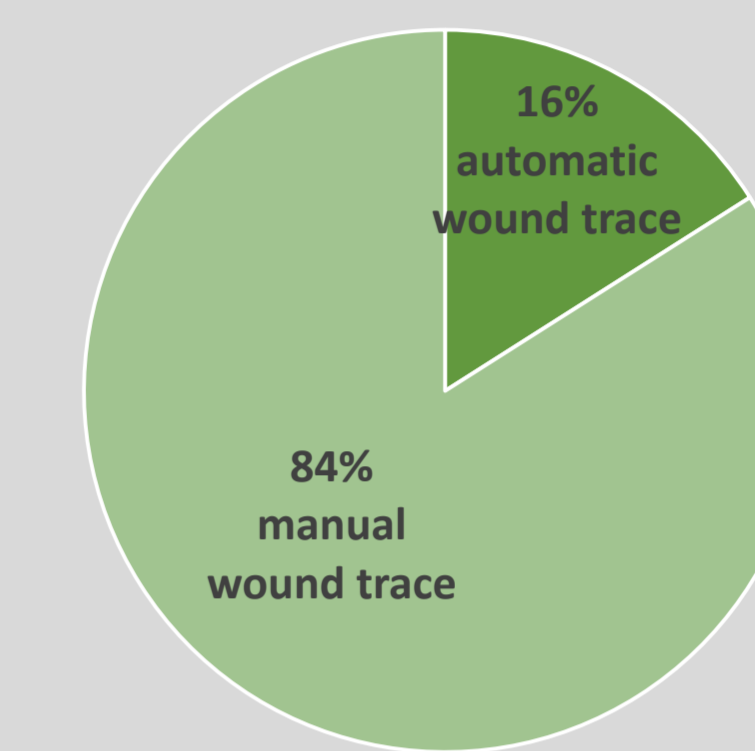
Use of automatic vs. manual wound trace
N = 25

The MolecuLight i:X imaging device allows for automatic and manual tracing of the wound, of which the manual trace was most frequently used in this patient population.
